TECHNICAL BULLETIN
JTB00275NAS2
24 OCT 2013

SECTION: 501-10

Folding Tray Latch Broken

XJ Range (X351)

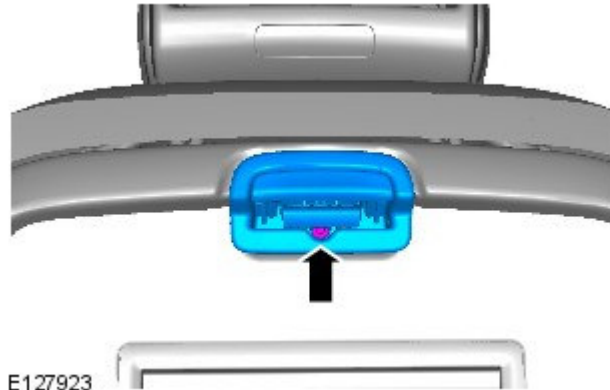
E127923

Cause: This may be caused by washers fitted behind latch, resulting in increased force at latch fixing point.

**NOTE: Discard any washers found behind the fixing.**

Remove and discard the folding tray latch.

- Remove the fixing.
