TECHNICAL BULLETIN
JT B00283NAS1
19 FEB 2013

Folding Top Glass-to-Top Bonding

XK Range (X150) - Convertible only

Model Year: 2007-2012

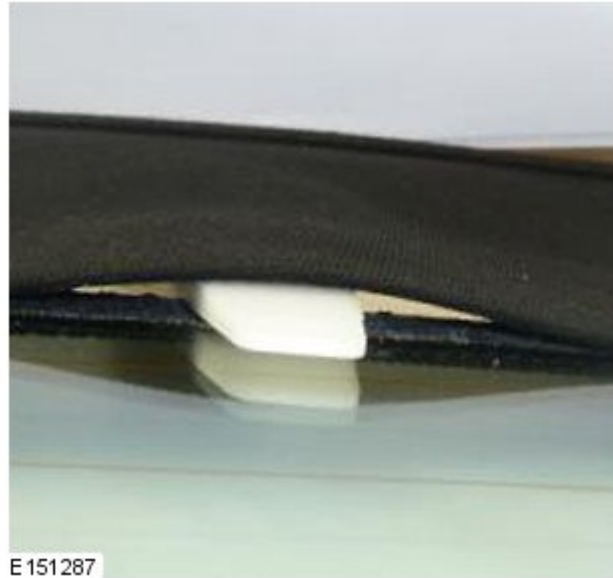
E 151287

The bonding between the folding top and the rear glass may require repair.

Cause: This may be caused by bonding robustness between the folding top and the rear glass.

Folding top glass-to-top bond.

- NOTE:** The maximum length of any one (1) area that can be re-bonded is 350mm (13.75in); up to a maximum of three (3) repairs around the glass are permitted.

NOTE: Plastic peg only for clarity of repair area.
