TECHNICAL BULLETIN
JTBO0250NAS2
04 MAR 2014

A-Pillar 'Creak' Noise

XJ Range (X351)

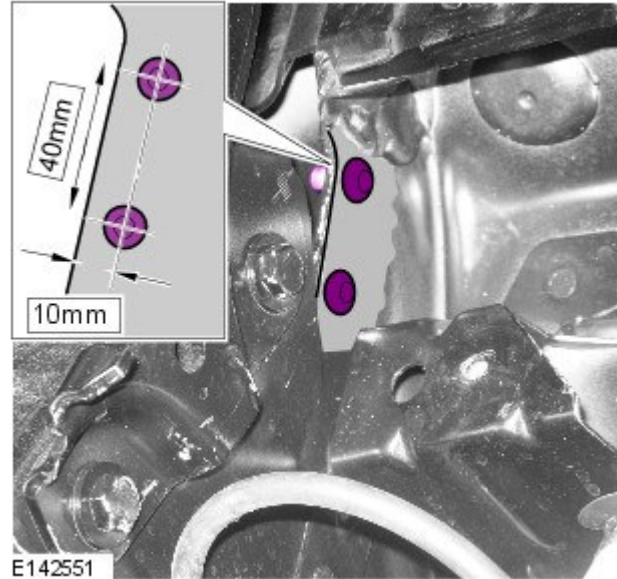
A 'creak' noise from the right-hand (RH) A-pillar may be heard from inside the vehicle.

Cause: This may be caused by the bonded body panels at the seam joint.

1. Remove the Engine Control Module (ECM) for access (see TOPIx Workshop manual, section 303-14).
2. Using suitable tape, tape up the air box to avoid swarf contamination from drilling.
3. Measure 10mm from the panel edge .

- Using a suitable tool, mark the first fixing.
- Measure and mark the second fixing 40mm from the first fixing.

4. Using a suitable 6.5mm drill, drill out the marked fixings.
5. Clean the drilled holes (De burr).
6. Using a suitable sealant, apply sealant to the raw edges of the drilled holes.
