# Service Bulletin

Bulletin No.: 01-08-42-001J

**Subject:** Exterior Lamp Condensation and Replacement Guidelines

**Models:** 2015 and Prior GM Passenger Cars and Trucks

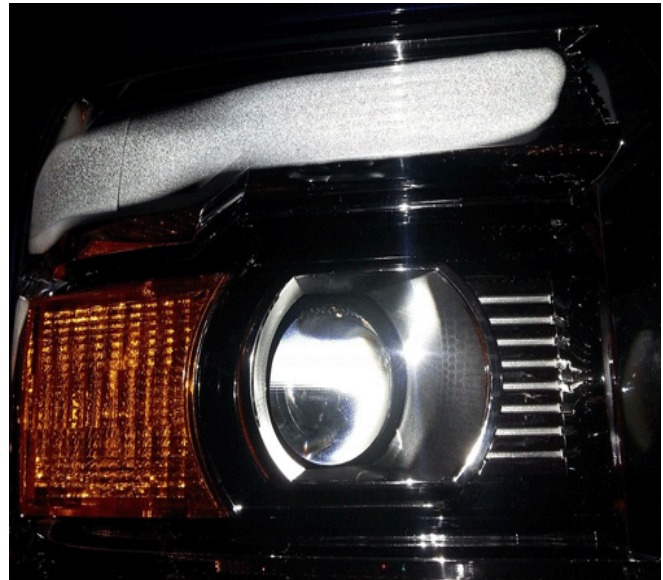
#### 2014 Sierra Headlamp, Full and Partial Examples

### A Fine Mist or White Fog on the Inside Surface of the Lamp Lens Occurring After a Period of High Humidity

- May be located primarily in the lens corners (near the vents) and SHOULD NOT cover more than half the lens surface.
- The condition should clear of moisture when the vehicle is parked in a dry environment, or when the vehicle is driven with the lights ON.
- A comparison of the equivalent lamp on the opposing side of the vehicle indicates a SIMILAR performance.

If the above conditions are noted, the customer should be advised that replacement of a lamp assembly may not correct this condition.

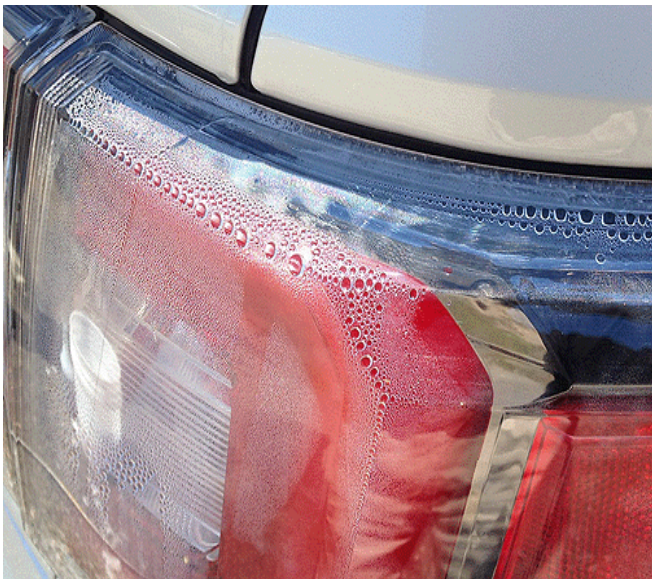
#### 2014 Acadia Tail Lamp Example

### Numerous & Various Size Drops of Water Collecting on the Inside Surface of the Lamp Lens After the Vehicle Has Been Exposed to Rain or a Car Washing Environment

- A condition that covers more than half the surface of the lamp lens.
- An accumulation of water in the bottom of the lamp assembly.

- A condition that WON'T clear when the vehicle is parked in a dry environment, or when the vehicle is driven with the lights ON.
- A comparison of the equivalent lamp on the opposing side of the vehicle indicates a different performance.

**Note:** Any of the conditions listed below would indicate the need to service the lens or lamp assembly.

**If a lamp is found to be exhibiting a leak, review the most recent version of Service Bulletin 02-08-42-001 for information regarding impact damage inspection.**
