Service Bulletin

Bulletin No.: 08-03-10-006E

Subject: Tire Slowly Goes Flat, Tire Air Loss, Low Tire Pressure Warning Light Illuminated, Aluminum Wheel Bead Seat Corrosion (Clean and Resurface Wheel Bead Seat)

Models: 2005-2015 GM Passenger Cars and Light Duty Trucks

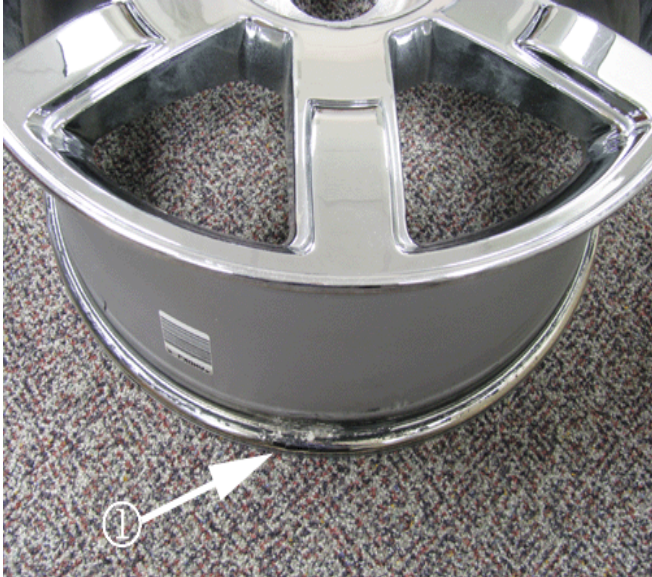
2103715

1. Remove the wheel and tire assembly for diagnosis. Refer to Tire and Wheel Removal and Installation in SI.
2. After a water dunk tank leak test, if you determine the source of the air leak to be around the bead seat of the wheel, dismantle the tire to examine the bead seat. Shown below is a typical area of bead seat corrosion.

Typical Location of Bead Seat Corrosion

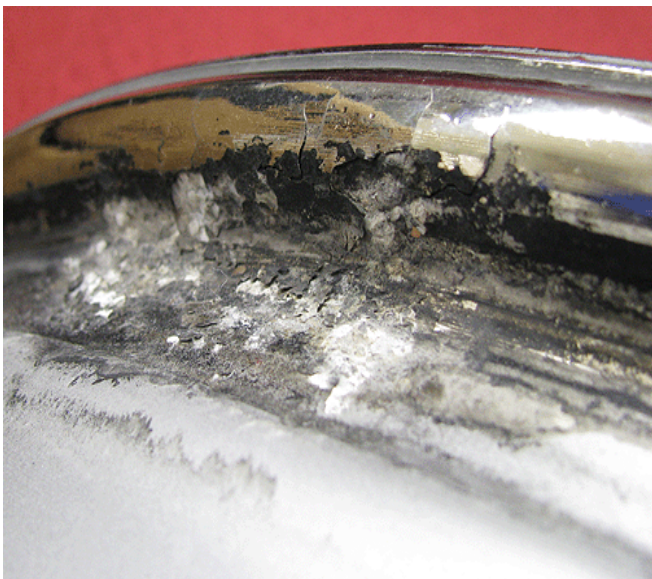
2103722

3. Bead seat corrosion is identified by what appears like blistering of the wheel finish, causing a rough or uneven surface that is difficult for the tire to maintain a proper seal on. Below is a close-up photo of bead seat corrosion on an aluminum wheel that was sufficient to cause slow air loss.

Close-Up of Bead Seat Corrosion

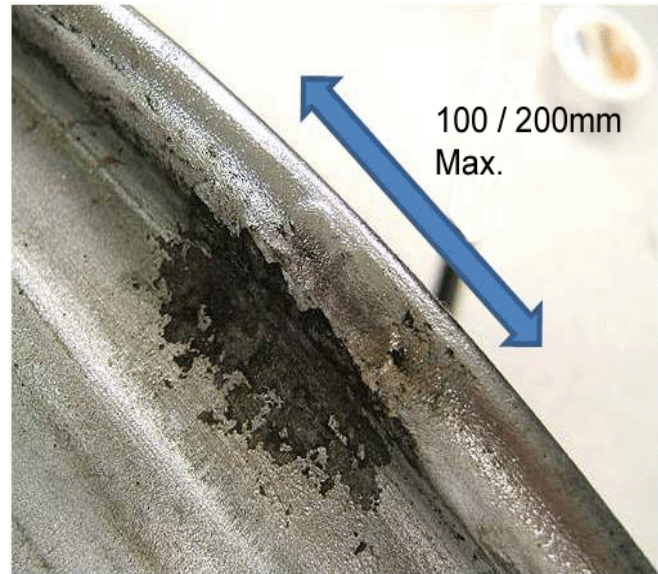
2365347

4. If corrosion is found on the wheel bead seat, measure the affected area as shown below.

- For vehicles with 32,186 km (20,000 mi) or less, the total allowable combined linear area of repairable corrosion is 100 mm (4 in) or less. If the total area(s) of corrosion exceed these dimensions, the wheel should be replaced.

- For vehicles that have exceeded 32,186 km (20,000 mi), the total allowable combined linear area of repairable corrosion is 200 mm (8 in) or less. If the total area(s) of corrosion exceed these dimensions, the wheel should be replaced.

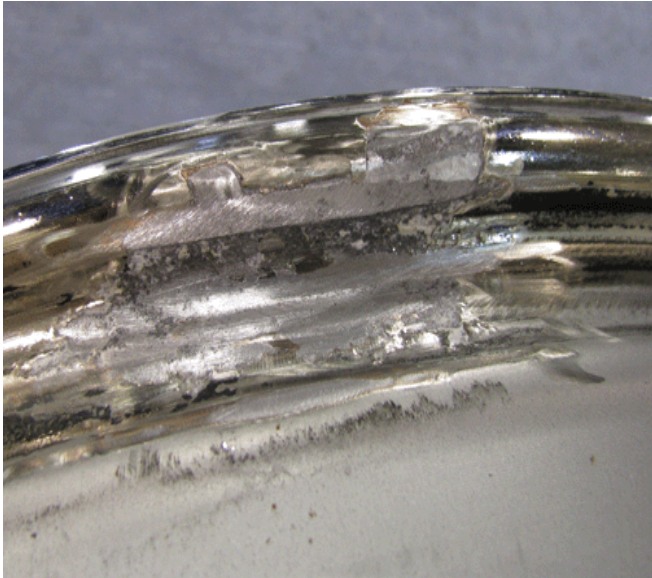
2103726

Acceptably Prepared (Cleaned-Up) Wheel Surface

5. In order to correct the wheel leak, use a clean-up (fine cut) sanding disc or biscuit to remove the corrosion and any flaking paint. You should remove the corrosion back far enough until you reach material that is stable and firmly bonded to the wheel. Try to taper the edge of any flaking paint as best you can in order to avoid sharp edges that may increase the chance of a leak reoccurring. The photo below shows an acceptable repaired surface.

Important: Remove ONLY the material required to eliminate the corrosion from the bead seating surface. DO NOT remove excessive amounts of material. ALWAYS keep the sealing surface as smooth and level as possible.

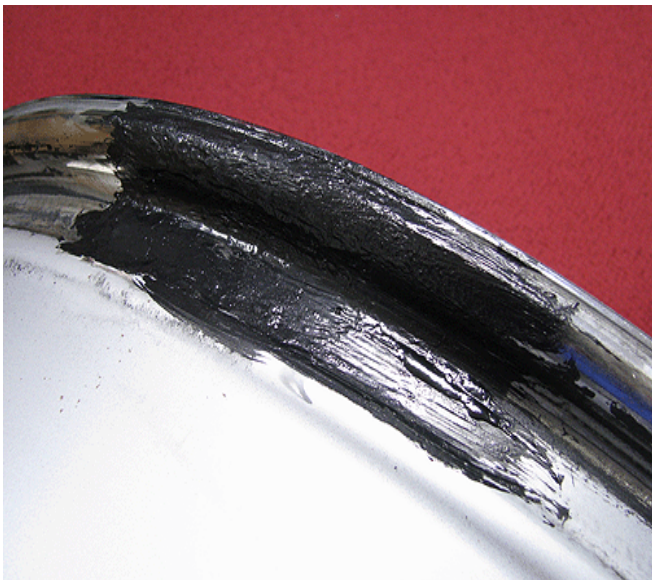
2103731

Coated and Sealed Bead Seat

6. Once the corrosion has been eliminated, you should coat the repaired area with a commercially available tire sealant such as Patch Brand Bead Sealer or equivalent. Commercially available bead sealants are black rubber-like coatings that will permanently fill and seal the resurfaced bead seat. At 21°C (70°F) ambient temperature, this sealant will set-up sufficiently for tire mounting in about 10 minutes.
