NUMBER: 23-026-14

Wind Noise At The Left And/Or Right Door

2014	(LC)	Challenger
2015	(LA)	Challenger

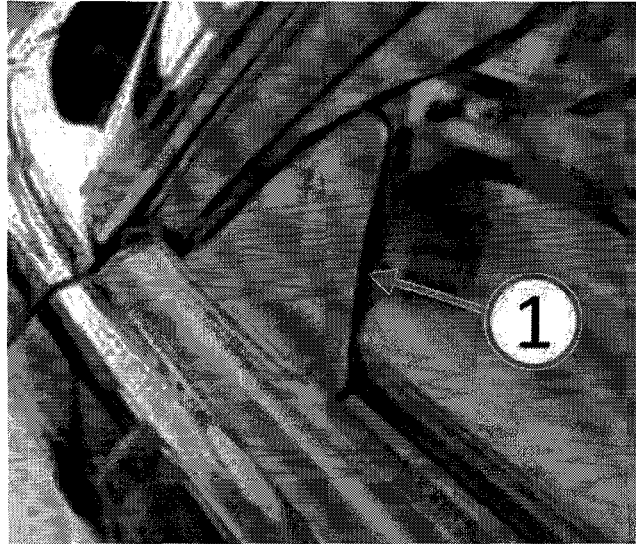
Fig. 1 Window Flag Gap Inspection

1. Raise the door window glass to the full up position.
2. Inspect both doors for a gap between the outer door mounted window seal flag and the door window glass (Fig. 1).

1 - Gap

-
3. Is there a gap between the outer door mounted window seal flag and the door window glass?
 - a. YES>>> Continue with the Repair Procedure.
 - b. NO>>> This Bulletin does not apply. Further diagnosis is required.
 4. Fully lower the door window glass.
 5. Apply slight pressure to the outboard side of the seal flag. This will reposition the metal tab inside the seal flag moving the seal flag tighter to the glass surface (Fig. 2).

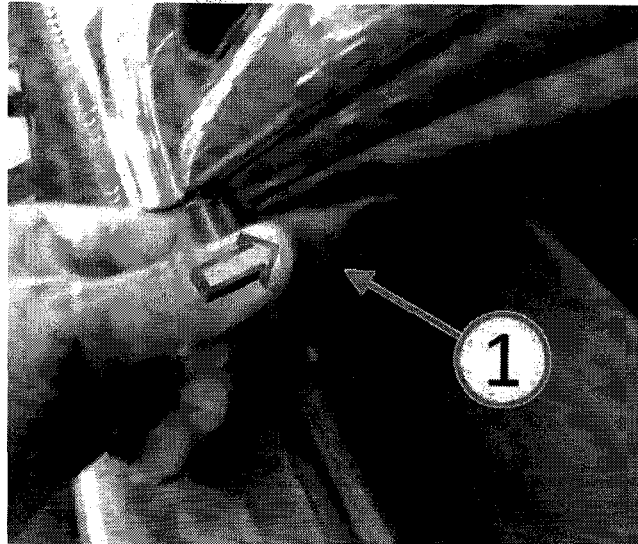
Fig. 2 Push In On The Window Flag

1 - Seal Flag

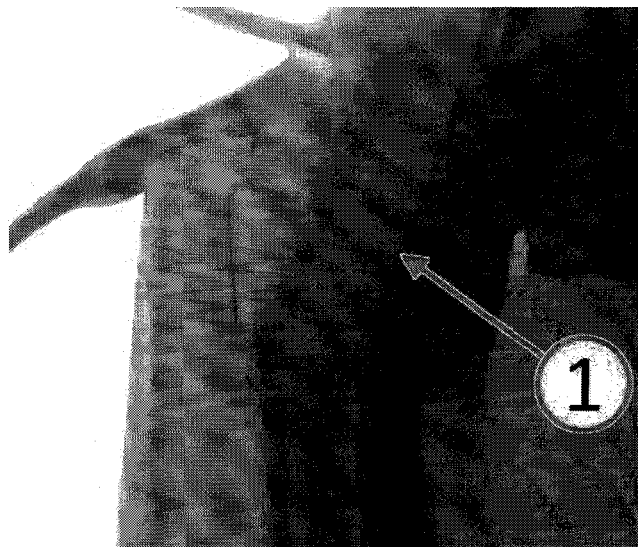
Fig. 3 Window Flag In Proper Position

1 - No Visible Gap

-
6. Raise the door window glass to the full up position.
 7. Confirm that the gap has been eliminated between the outer door mounted window seal flag and the door window glass (Fig. 3).

-
8. If no gap is observed, confirm the customer's wind noise complaint has been resolved.
