NUMBER: 23-029-13
GROUP: Body
DATE: August 06, 2013

Side Door Glass Is Inoperable, Binds And/Or Moves Slow

2012- 2013 FF Fiat 500

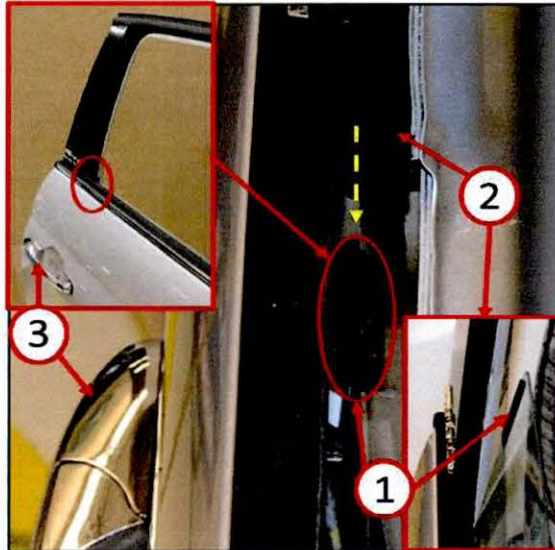
Fig. 1 Glass Removal

NOTE: The door glass must be lowered enough to drop the rear upper plastic bracket/guide out the bottom of the door glass run. The window regulator may need to be removed if the glass can not be lowered safely past/below the regulator (**Fig. 1**).

1. Remove the suspect left and/or right side door glass. Refer to the detailed removal procedures available in DealerConnect>TechCONNECT> under: Service Info> 23-Body> Door - Front > GLASS, Door> Removal.

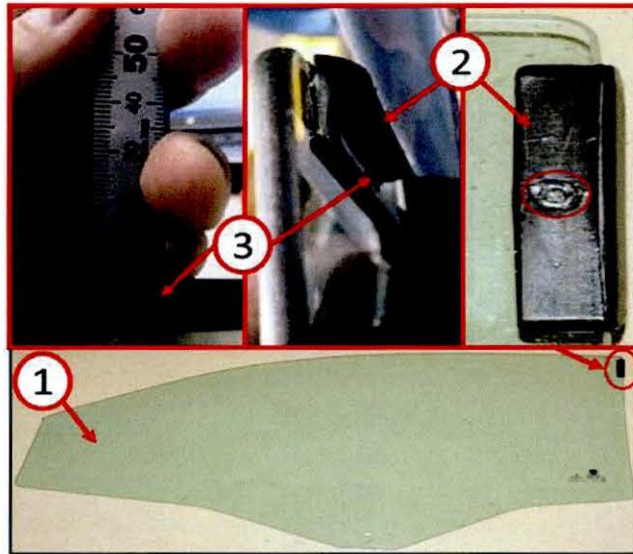
Fig. 2 Glass Guide Inspection

2. Inspect the suspect door glass plastic bracket/guide (2) for excessive material at the plastic/sonic weld (3) (Fig. 2).

NOTE: Door glass plastic bracket/guide should be flush or have no more than a maximum of 0.2mm protrusion at the plastic/sonic weld.

-
3. Does the window bracket/guide have excessive material protrusion?
 - a. Yes>>>Replace the suspect left and/or right side door glass and weatherstrip run(s). Proceed to [Step #4](#).
 - b. No>>> Further diagnosis required. Proceed to [Step #6](#) to reinstall the door glass.

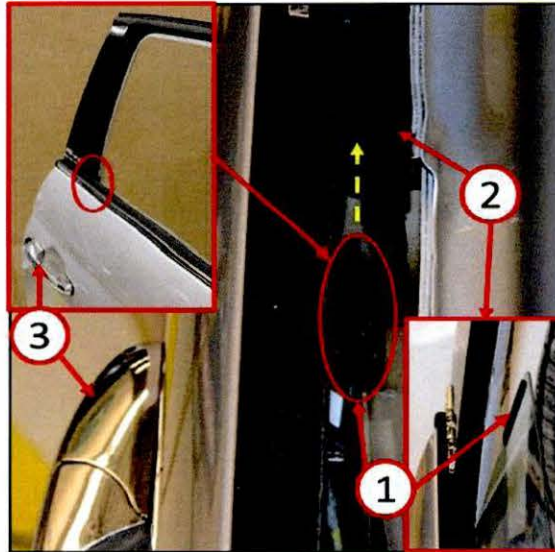
Fig. 5 Glass Installation

NOTE: The door glass must be lowered enough to allow the rear upper plastic bracket/guide to be inserted in the bottom of the door glass run to prevent damaging the plastic guide. The window regulator may need to be removed if the glass can not be lowered safely past/below the regulator (**Fig. 5**).

6. Install the left and/or right door glass. Refer to the detailed installation procedures available in DealerConnect>TechCONNECT> under: Service Info> 23-Body> Door - Front> GLASS, Door> Installation.

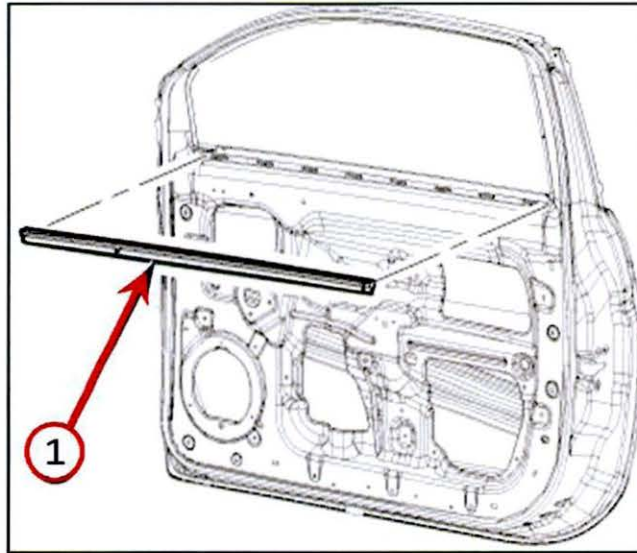
Fig. 6 Inner Belt Mold Installation

NOTE: Make sure that the inner belt mold (1) is reinstalled correctly as it is possible to be incorrectly installed (upside down). If installed incorrectly, this may affect glass movement once the door panel is reinstalled (Fig. 6).
