NUMBER: 23-031-13
GROUP: Body
DATE: August 29, 2013

SUBJECT:
Second Row Headrest Creak And/Or Squeak

OVERVIEW:
This bulletin involves inspecting and if necessary replacing the second row left and right headrest mechanism.

2013	WD	Durango
2013	WK	Grand Cherokee

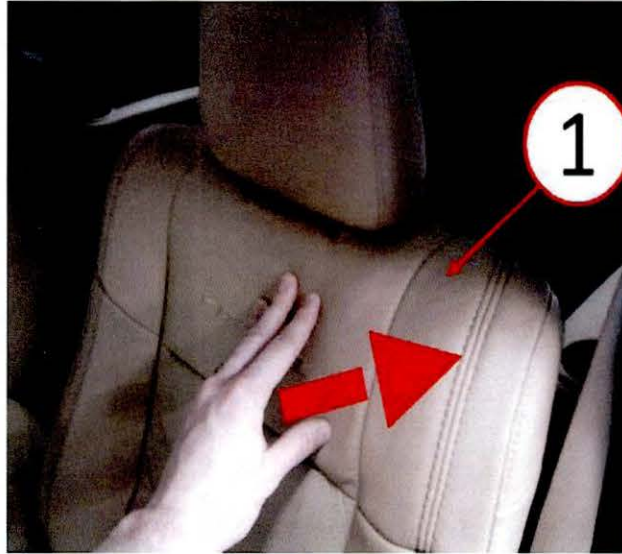
Fig. 1 Inspection

1. Push on the left and then right side of the 2nd row upper seat back just under the headrest as shown in (Fig. 1). Did a metal to metal squeak sound occur?
 - a. Yes>>> Proceed to Step #2.
 - b. No>>> This bulletin does not apply, continue further diagnosis.
