SERVICE BULLETIN

APPLICABILITY: 2013MY Legacy and Outback Models
 Equipped With 2.5L FB Engine

NUMBER: 11-122-12

SUBJECT: Difficulty Starting, Rough Idle, Cam Position or
 Misfire DTCs
 DTCs P0340, 341, 345 or 346, P0301, 302, 303 or 304

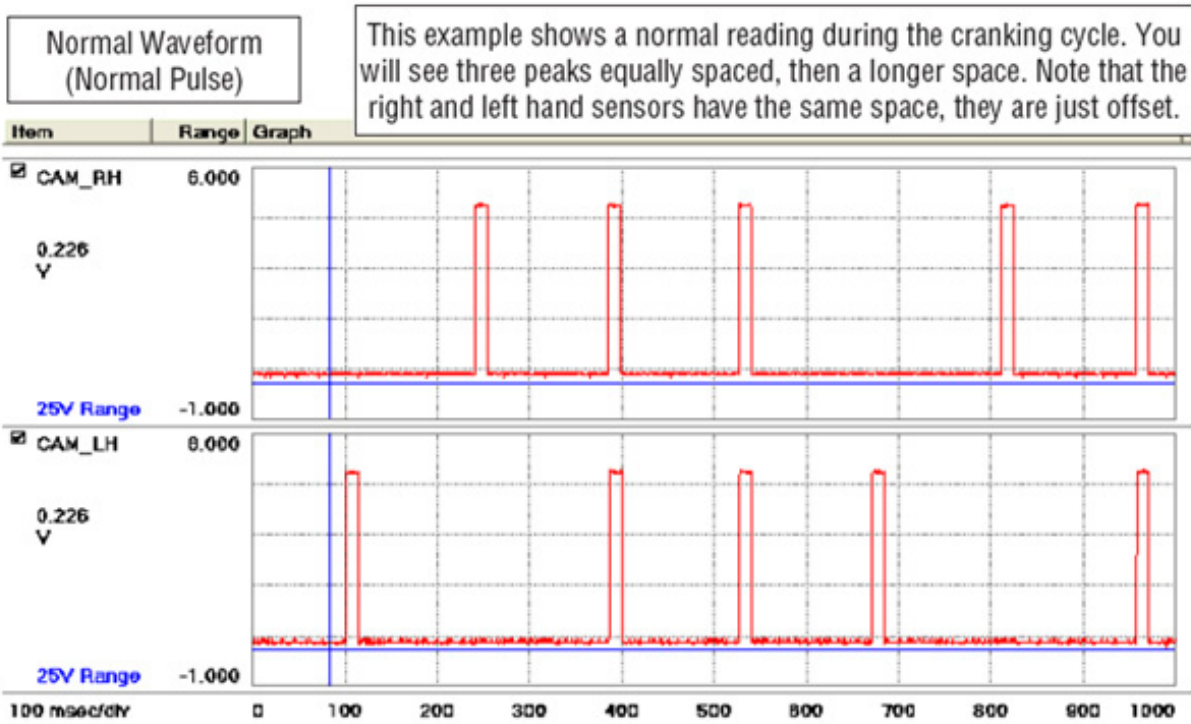
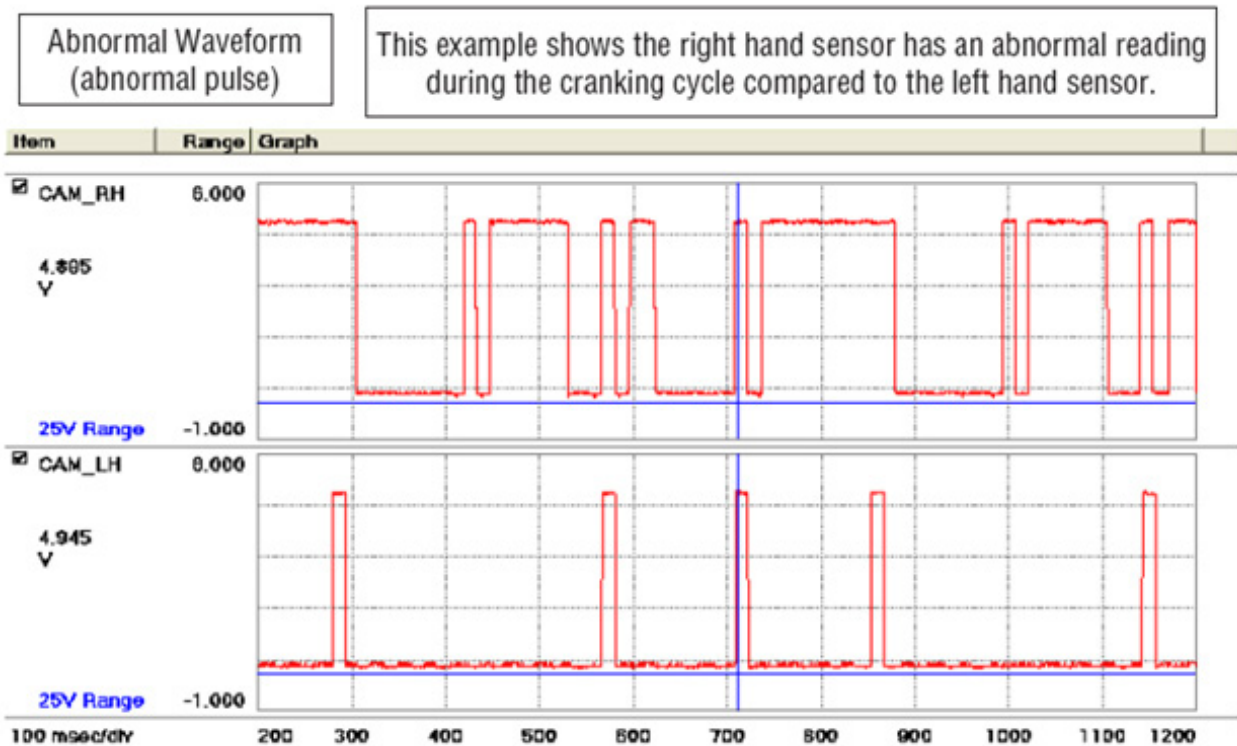
The following illustrations show a normal oscilloscope pattern followed by an abnormal pattern.

If an abnormal pattern is verified similar to those shown in the illustration above, measure the clearance between the end of the camshaft position sensor and the sensor plate using the following procedure. If the oscilloscope pattern is normal, refer to the applicable Service Manual for additional troubleshooting and diagnostic procedures.

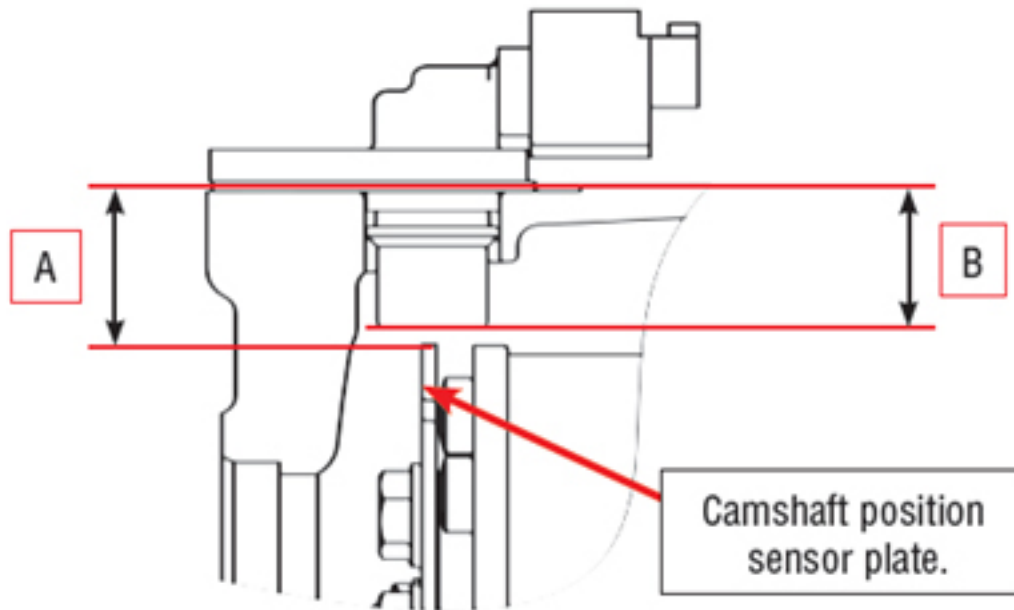
MEASUREMENTS:

A= Top surface of the timing chain cover to camshaft sensor plate

B= Camshaft Position Sensor mating surface to the bottom of the sensor

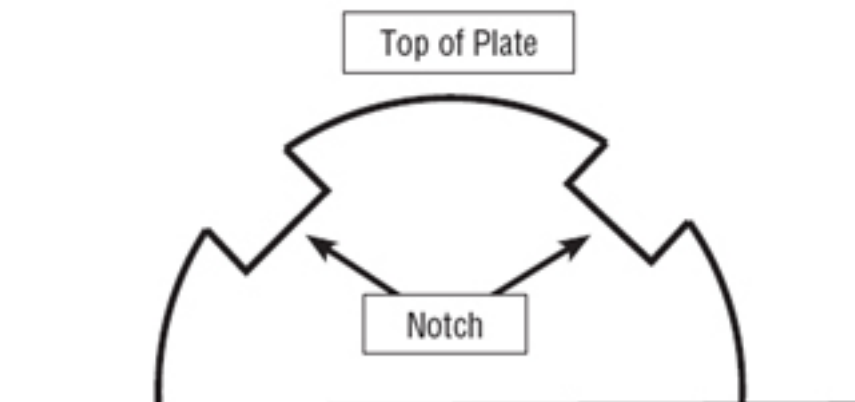
NOTE: When measuring “A”, make sure you are measuring to the outside diameter or “top” of the sensor plate and not to the bottom of a notch as shown below. Be sure to record all measurements.
