TECHNICAL BULLETIN
JTB00346NAS1
28 APR 2014

SECTION: 501-00

Transit Protection / Wrapguard Staining

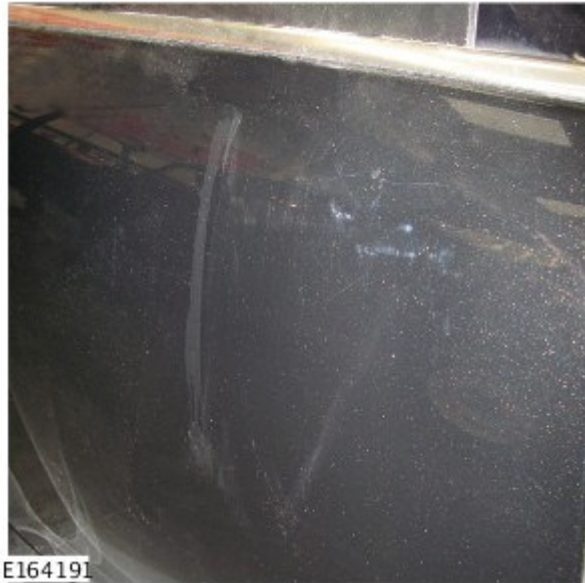
Situation: At Pre-Delivery Inspection (PDI) upon removal of the transit protection / wrapguard, there may be paint stains underneath the wrapguard. This staining can be described as 'bloom' or a 'milky' type of stain.

Cause: This may be caused by moisture being trapped under the transit protection / wrapguard. .

1. Fully remove the transit protection / wrapguard from the vehicle.
2. Inspect vehicle for 'bloom' or a 'milky' type of stain.

Subject the vehicle to a 30-minute bake cycle at 140°F / 60°C in a conventional spray booth.

- If a conventional spray booth is not available, apply localized heat from an infrared curing unit.

4. Once cool, polish the affected area.
