TECHNICAL BULLETIN
K196NAS2
05 NOV 2014

Service Action: Seatback Business Tray

XJ Range (X351)

Model Year: 2012-2013
VIN: V28345-V58569

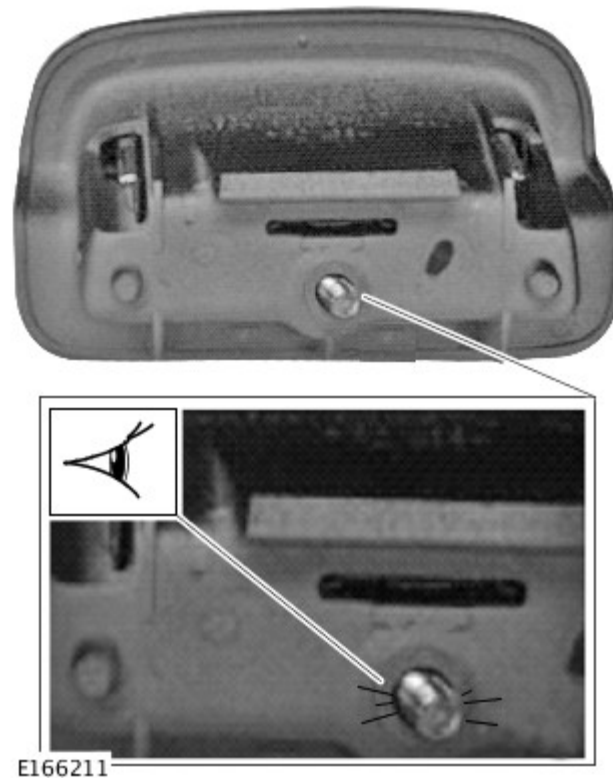
3. Inspect the business tray latch for cracks.

- If the latch is not cracked, continue to the next step.
- If the latch is cracked, continue to the next step using a **new** business tray latch.
