Technical Service Bulletin

87 Moisture in driver or front passenger footwell

87 12 34 2024644/5 November 9, 2012. Supersedes Technical Service Bulletin Group 87 number 12-31 dated September 5, 2012 for reasons listed below.

Model(s)	Year	VIN Range	Vehicle-Specific Equipment
A4	2009-2013	All	Not Applicable
A5	2008 - 2013		
A5 Cabriolet	2010 - 2013		
Q5	2009 - 2013

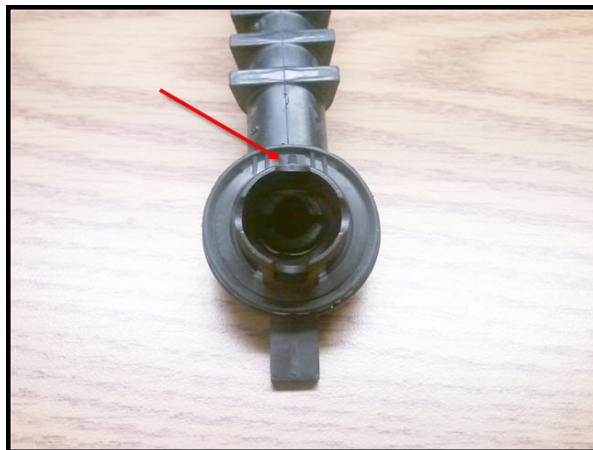
Due to a faulty and / or incorrectly installed condensation drain hose, condensation from the evaporator could enter the front foot well areas through a gap between the body and the sealing surface of the drain hose.

2. Inspect both drain hoses to identify if they are incorrectly assembled. An incorrectly assembled condensation drain hose is one where the locating tab is pointing up as seen in Figure 1. The correct orientation for this locating tab should be pointing down.

Figure 1. Incorrectly assembled drain hose, with locating tab pointing up.

3. Should the snap ring have been incorrectly installed to the body of the vehicle, do not repair the condensation drain hose assembly. Replace the hose using the repair procedure in *ElsaWeb >> Heating, Ventilation and Air Conditioning >> 87 Air Conditioning >> Removal and Installation >> Condensation Water Drain Hose*. Improper installation at the factory may have damaged the snap feature (opposite the locating tab), thus creating a poor seal to the body.

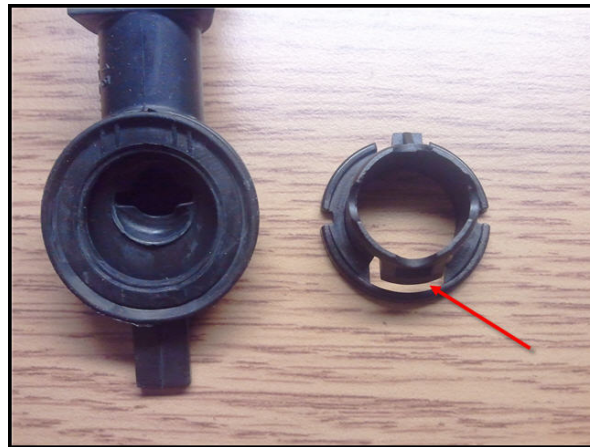
When the snap ring is installed upside down, it allows condensation to leak out through a hole at the bottom of the snap ring (Figure 2). The water can then migrate into either of the front footwell carpeted areas.

Figure 2. Hole in snap ring.

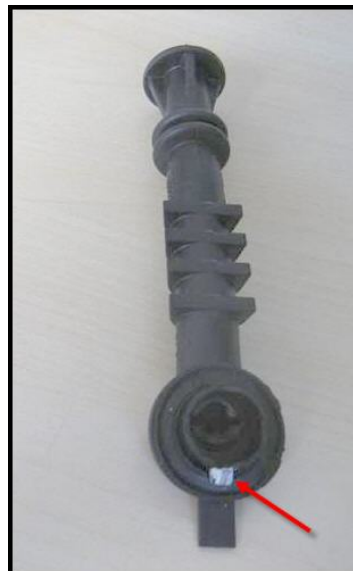
Service parts have been checked, but it is still possible to receive unchecked parts. Corrected parts will be marked in white on the locating tab. This tab must be pointing down (Figure 3).

Figure 3. White mark on locating tab.
