# Technical Service Bulletin

## 91 Bluetooth call quality issues for caller on other end of call

91 12 68 2027718/3 November 12, 2012. Supersedes Technical Service Bulletin Group 91 number 12-53 dated August 6, 2012 for reasons listed below.

Model(s)	Year	VIN Range	Vehicle-Specific Equipment
2011-2013	A6/A7	N/A	Bluetooth Hands-Free Calling
2011-2013	A5 CAB		
2011-2013	TT

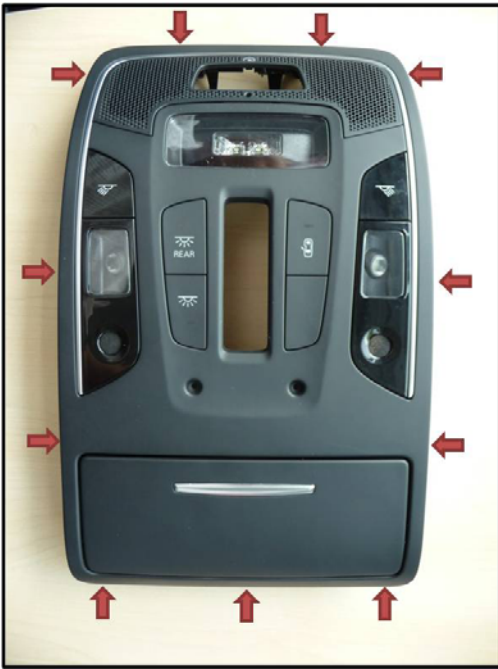
Figure 1. A6, A7 High line roof module.

- a For the A6 and A7 vehicles, first attempt to use your fingers to pry the decorative trim from the base plate. If this does not work then gently use a trim stick/bone tool to pry the decorative trim from the base plate and finish it with your fingers. There are a different number of clips holding the trim plate on to the base plate depending on the trim level of the vehicle (i.e. high-line roof module vs. low-line roof module; see Figure 1 & 2).

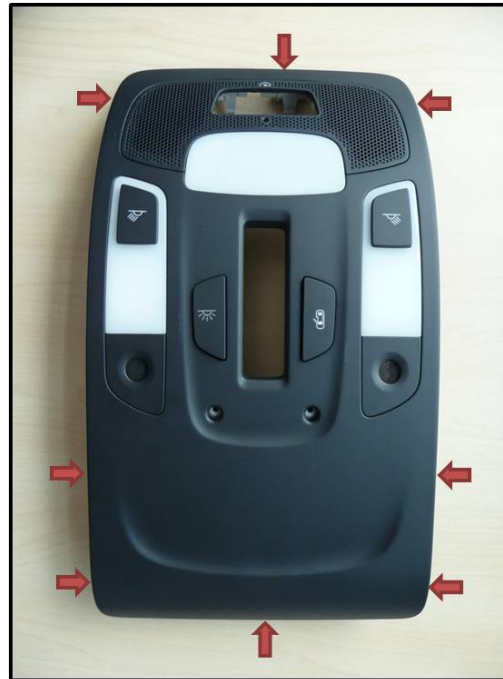
Figure 2. A6, A7 Mid line roof module.

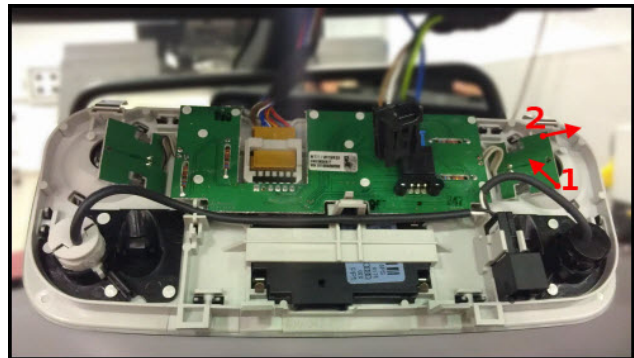
**Figure 3.** *Prying the LED circuit-board of the jewel.*

- b For the TT/A5 Cabriolet vehicles, the decorative trim plate *should only be pried from the base plate after the LED circuit boards are removed from the plastic LED jewels*. If this is not done prior to removing the trim, the plastic LED jewels can break and cause a rattle once the roof module is reassembled. As seen in Figure 3, first pry up on the top of the small circuit-board in direction indicated by arrow 1 (away from LED Jewel). It will only need to be lifted about 1-2mm, then pull up on the circuit-board in the direction indicated by arrow 2. This will release the circuit-board from the clear LED jewel. Repeat for the other side. Figure 4 shows the three attachment points of the LED Circuit board to the LED jewel.

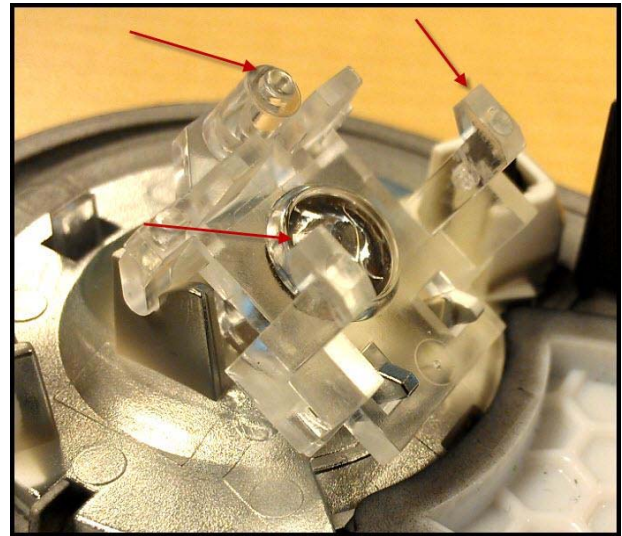
**Figure 4.** *LED jewel attachment points.*

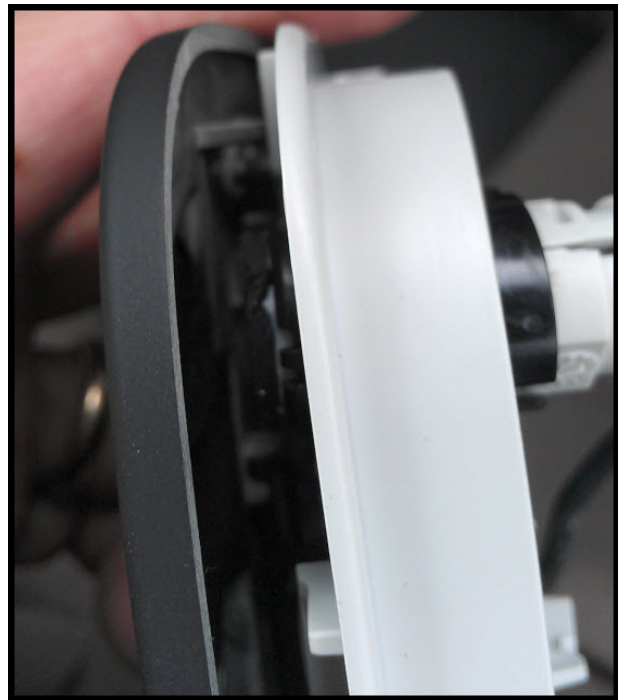
*Figure 5. Prying the trim plate from the base plate.*

- c Once the LED jewels are free from the circuit-boards, the decorative trim plate can now be pried apart from the base plate. This can be accomplished by using your fingers and slowly prying the two pieces apart. There are many clip points along the edge holding the two halves together, thus slowly sliding your finger all the way around the perimeter between the trim plate and base plate is the easiest and most effective way to separate the two parts without damaging them.

The use of a bone tool or screw driver is not recommended for this roof module assembly because it can damage the soft touch paint on the edge of the decorative trim. Damage to paint on the sides of the trim can be visible once the part is reinstalled in the headliner.

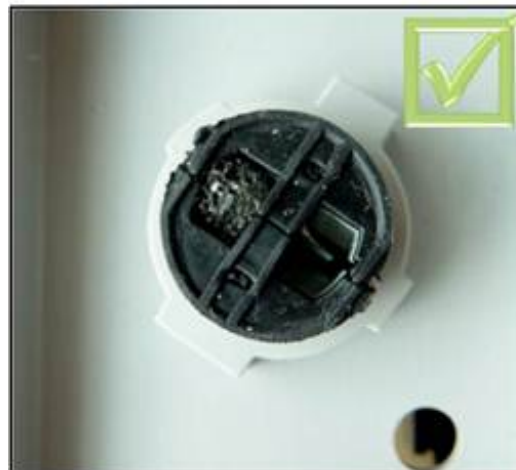
4. Inspect the seal of the microphone for damage. There are two normal splits in the rubber seal. This is normal as long as the two halves of the seal are touching each other. If they are loose and move freely then this indicates damage to the seal. Figure 6 illustrates an undamaged seal and Figures 7 and 8 illustrate *damaged* seals.

*Figure 6. Undamaged seal.*

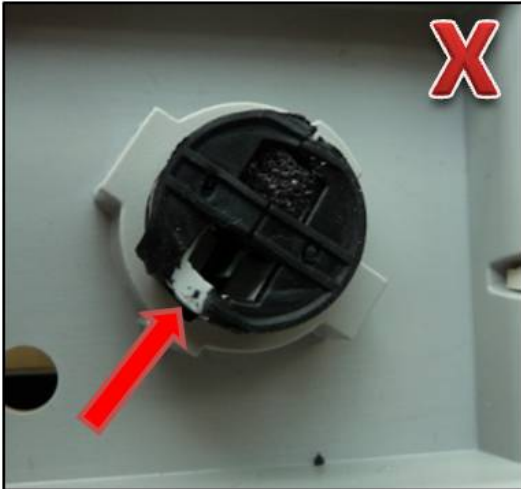
The microphone seal is damaged during installation in to the roof module.

*Figure 7. Damaged seal, example 1.*

5. If any seals are damaged, replace the microphone set. Install the replacement microphone with the decorative trim removed from the base plate. This will allow you to inspect the new microphone seal after it has been snapped in to place. Take care when doing so to prevent any damage to the new microphone's rubber seal. Installing it perpendicular to the base plate, and doing so slowly, will help prevent any damage to the seal. Figure 9 illustrates the proper installation technique and Figures 10 and 11 illustrate the *improper* installation of a microphone. Figure 12 shows the resultant damage of improper installation.

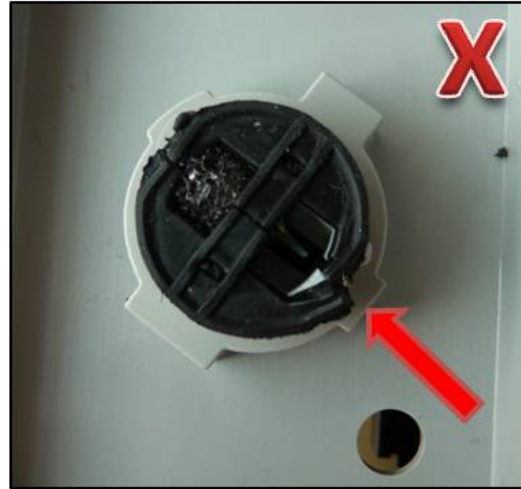
*Figure 8. Damaged seal, example 2.*

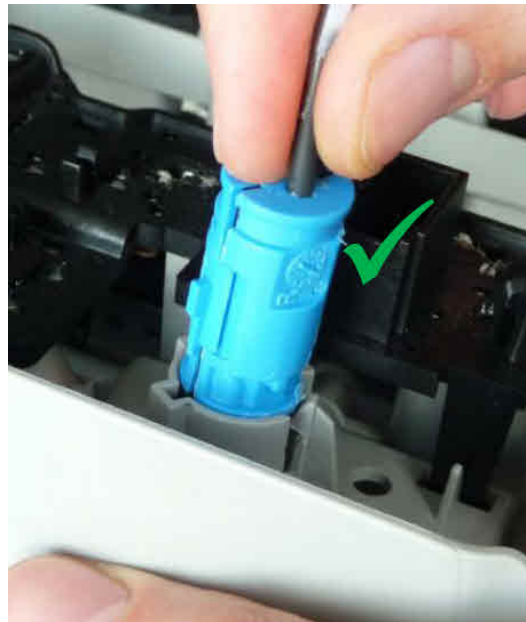
*Figure 9. Proper installation.*

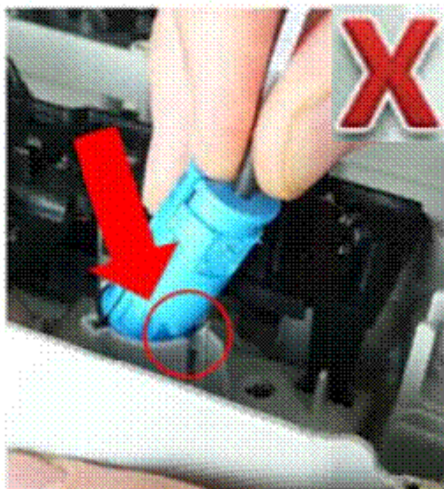
*Figure 10. Installing microphone at an angle.*

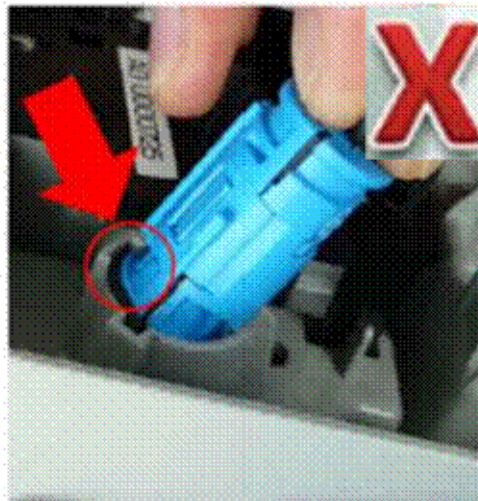
*Figure 11. Seal may be pinched.*

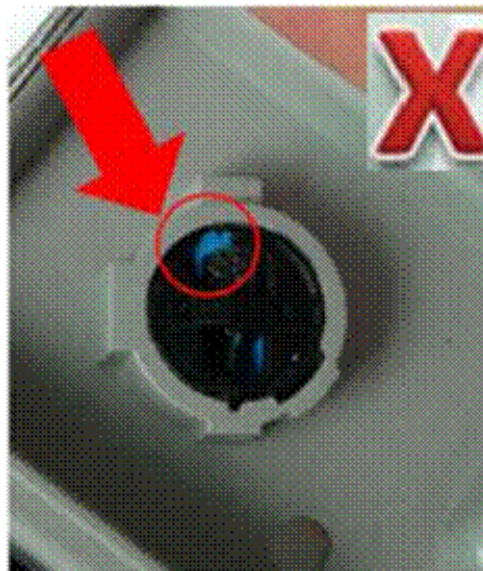
*Figure 12. Damage caused by pinched seal.*

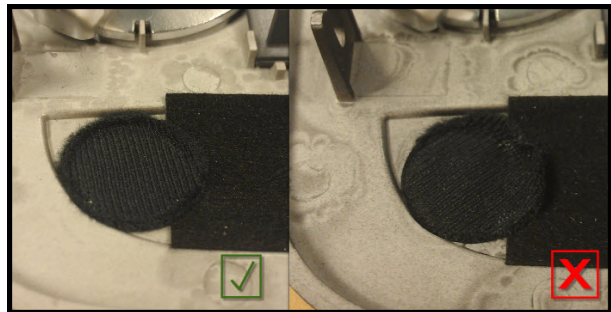
7. **For TT/A5 Cabriolet only:** Visually inspect the round felt material on the underside of the decorative trim (Figure 13). This felt material pushes against the microphone's rubber seal and forms a barrier. If the material is bunched up and off center it can potentially cause an issue with the call quality by allowing unwanted noise to reach the microphone. Replace the decorative trim according to ETKA if damage is found with the felt material or if the felt is not centered perfectly.

*Figure 13. Felt on backside of decorative trim.*

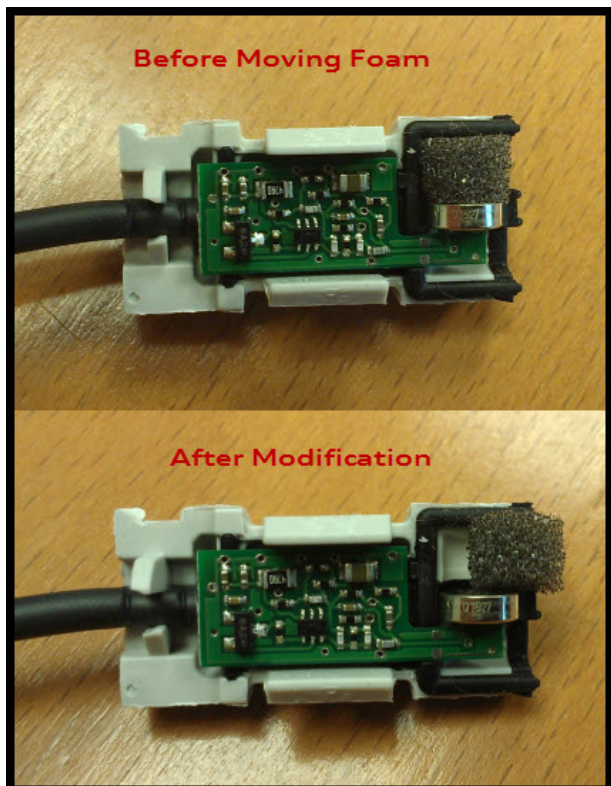
*Figure 14. Foam is partially pulled out of the microphone.*

8. **For TT/A5 Cabriolet only:** Before installing the new microphone, partially pull out the foam which is inserted inside the microphone (Figure 14). This will allow for a better seal against the felt material.
