# Technical Service Bulletin

## 01 MIL on (DTC P2006(00) or P2007(00) stored in ECM)

01 13 11 2033919/6 June 26, 2013. Supersedes Technical Service Bulletin Group 01 number 13-06 dated June 18, 2013 for reasons listed below.

Model(s)	Year	VIN Range	Vehicle-Specific Equipment
A6/A7, S4, S5, S5 Cabrio, Audi Q7, Audi Q5	2013	All	3.0 FSI Engine

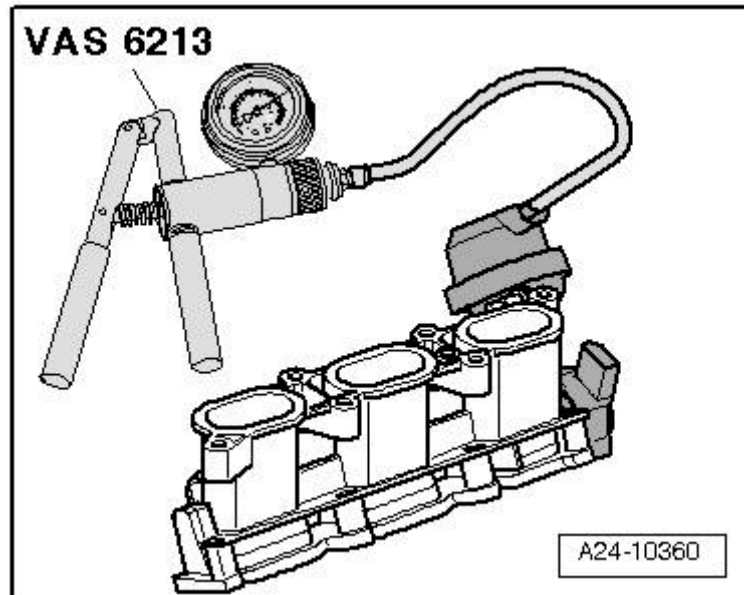
*Figure 1. Vacuum pump VAS 6213*

1. Ensure that the fault is not caused by a defective vacuum line by using the vacuum pump (Figure 1) to confirm there is no leak in the vacuum supply to the actuators.

The vacuum lines are working correctly if they are able to maintain vacuum while the actuators are disconnected and the lines are plugged up.

2. After confirming that the fault is not due to defective vacuum lines, replace **both** vacuum actuators (bank 1 and bank 2 actuator). This is to prevent any repeat repairs.
