Technical Service Bulletin

01 MIL on (DTC P2006(00) or P2007(00))

01 13 14 2033919/7 July 9, 2013. Supersedes Technical Service Bulletin Group 01 number 13-11 dated June 26, 2013 for reasons listed below.

Model(s)	Year	VIN Range	Vehicle-Specific Equipment
A6/A7, S4, S5, S5 Cabrio, Audi Q7, Audi Q5	2013 - 2014	All	3.0 FSI Engine

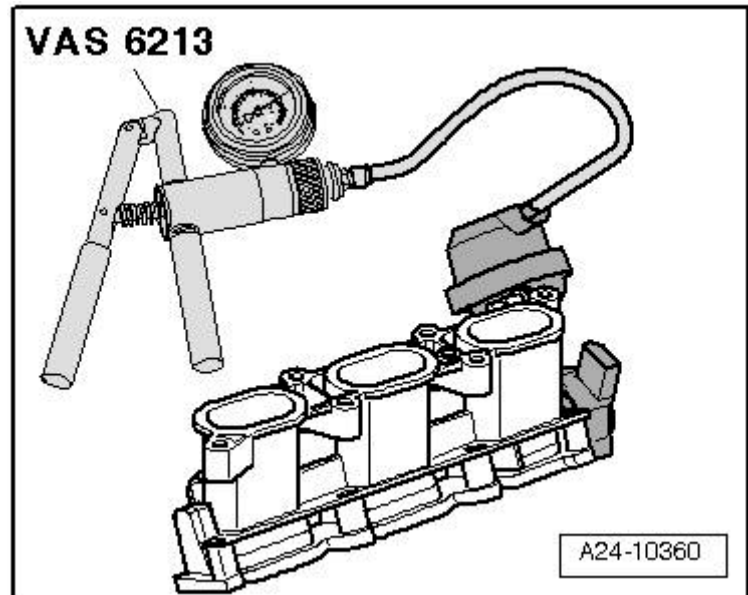
Figure 1. Vacuum pump VAS 6213

1. Ensure that the fault is not caused by a defective vacuum line by using the vacuum pump (Figure 1) to confirm there is no leak in the vacuum supply to the actuators.

The vacuum lines are working correctly if they are able to maintain vacuum while the actuators are disconnected and the lines are plugged up.

2. After confirming that the fault is not due to defective vacuum lines, replace **both** vacuum actuators (bank 1 and bank 2 actuator). This is to prevent any repeat repairs.
