Technical Service Bulletin

01 MIL on (DTC P2006(00) or P2007(00))

01 13 16 2033919/8 July 19, 2013. Supersedes Technical Service Bulletin Group 01 number 13-14 dated July 9, 2013 for reasons listed below.

Model(s)	Year	VIN Range	Vehicle-Specific Equipment
A6, A7, S4, S5, S5 Cab, Q7, Q5	2013	All	3.0 FSI Engine

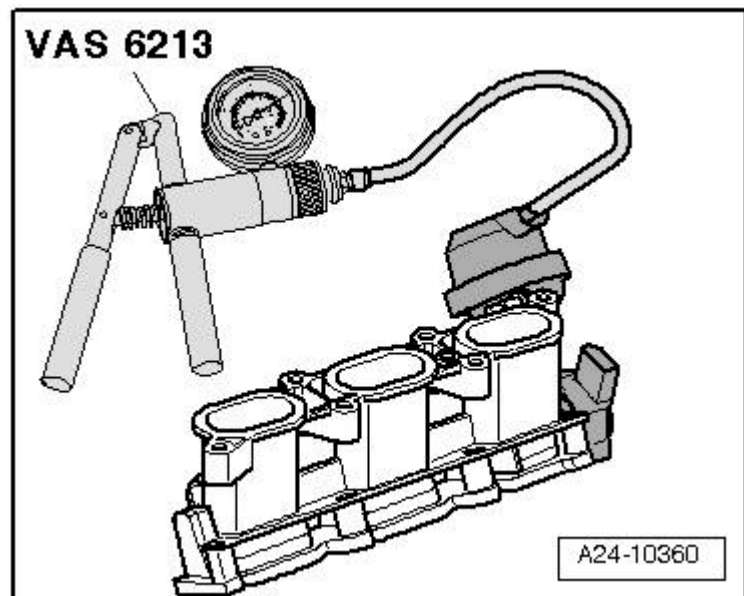
Figure 1. Vacuum pump VAS 6213

1. Ensure that the fault is not caused by a defective vacuum line by using the vacuum pump (Figure 1) to confirm there is no leak in the vacuum supply to the actuators.

The vacuum lines are working correctly if they are able to maintain vacuum while the actuators are disconnected and the lines are plugged up.
