## SERVICE BULLETIN

**APPLICABILITY:** 2013MY Legacy and Outback 2.5L Models  
 2012-13MY Impreza 2.0L Models  
 2013MY XV Crosstrek  
 2011-2014MY Forester  
 2013MY BRZ

**NUMBER:** 11-130-13R

**SUBJECT:** Difficulty Starting, Rough Idle, Cam Position or Misfire DTCs  
 P0340, P0341, P0345, P0346, P0365, P0366, P0390, P0391,  
 P0301, P0302, P0303 or P0304

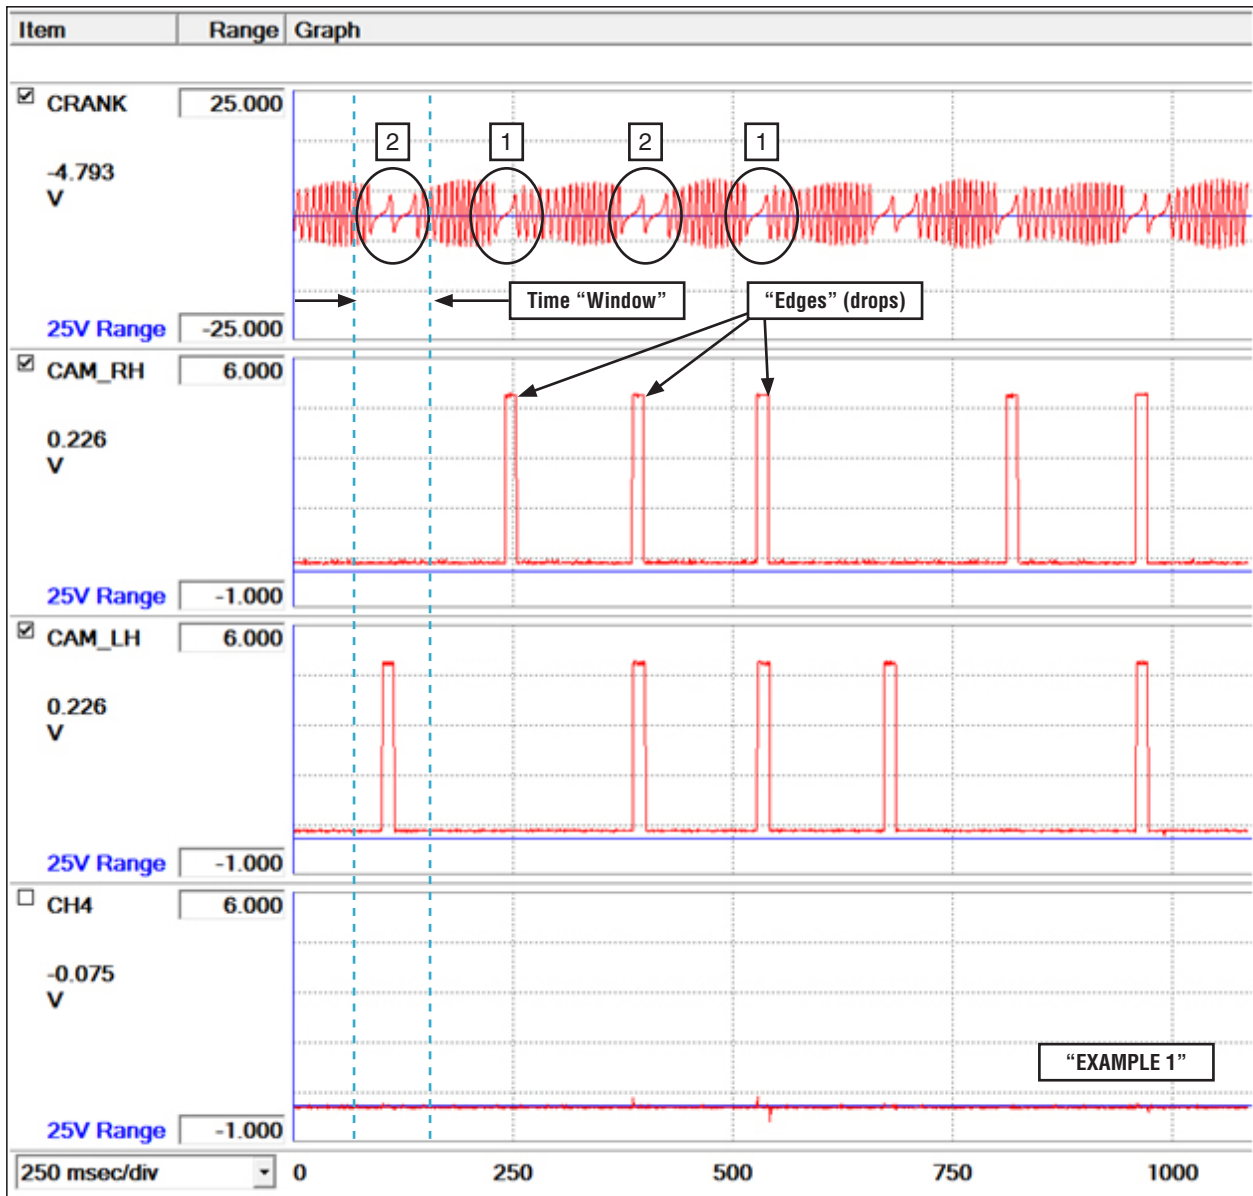
Looking at the crank signal on page 4, you will see the difference between what we will call “1’s” (a single spike) and “2’s” (a double spike). This helps establish the engine’s firing order and what the corresponding cam sensor data should look like. The ECM looks for the “Edges” of the cam position sensor voltage drops to be within specified time “Window” parameters. The chart below Example 1 on the next page will help bring this all together. (Range was set to 250 msec / div. so the crank signal would be easier to understand here.)

Engine Firing Order	#1	#3	#2	#4
Crank Signal ("1" or "2"?)	"1"	"2"	"1"	"2"
Is Cam Signal Edge Within Window RH?	Yes	No	Yes	Yes
Is Cam Signal Edge Within Window LH?	Yes	Yes	No	Yes

Using the chart above and comparing it to **Example 1**, it can be determined the first cylinder shown in the screen shot is #3 because the crank signal is a "2" and there is an edge signal within the window on the LH but not the RH cam sensor. Next cylinder in the firing order would be #2 as the crank position signal is a "1" and there is an edge signal in the window for the RH but not for the LH, and so on...

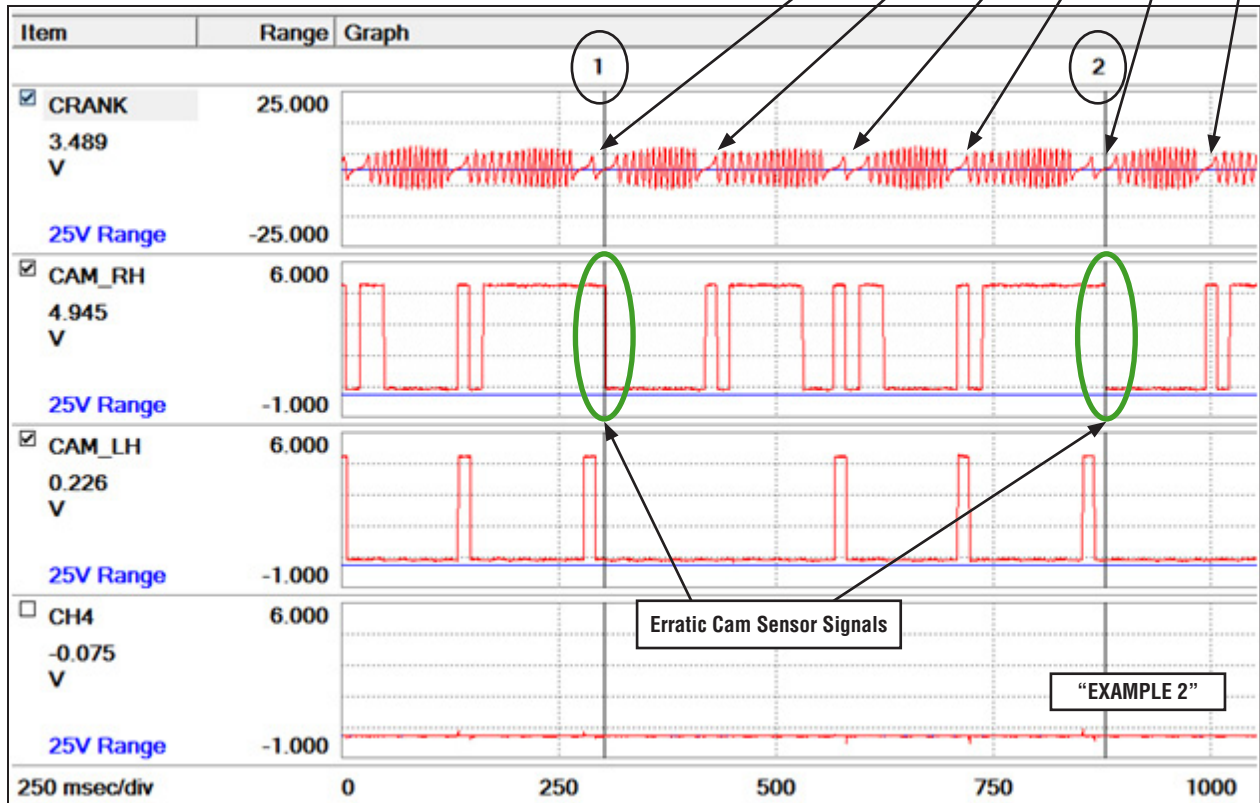
**Example 2** below shows a “Bad” pattern for the RH cam sensor. Marks #1 and #2 show what appears to be #4 cylinder firing but, the next cylinder to fire according to the screen shot is #2 followed by #4 then #1. The pattern for the RH sensor never shows the proper sequence to fire #3 cylinder. In this case, recheck the data again after installing a .2mm shim under the RH cam sensor.

**Proper Firing Order is:** #3 #2 #4 #1 #3 #2

**Firing Order shown in screen shot:** #4 #2 #4 #1 #4 #2

**IMPORTANT:** If you confirm an irregular wave form pattern, BEFORE performing the measurement and shim selection procedures, install a .2mm shim under the suspect intake or exhaust camshaft position sensor. If there is no change, remove the .2mm shim and install a .4mm shim. **USE ONLY ONE SHIM PER SENSOR, NO STACKING.** If the wave pattern is lost, remove the .4mm shim and replace with a .3mm shim. Recheck the pattern and if it appears normal, complete the repair as shown below. If an abnormal pattern persists, proceed with the rest of the clearance measurement and shim selection procedures.

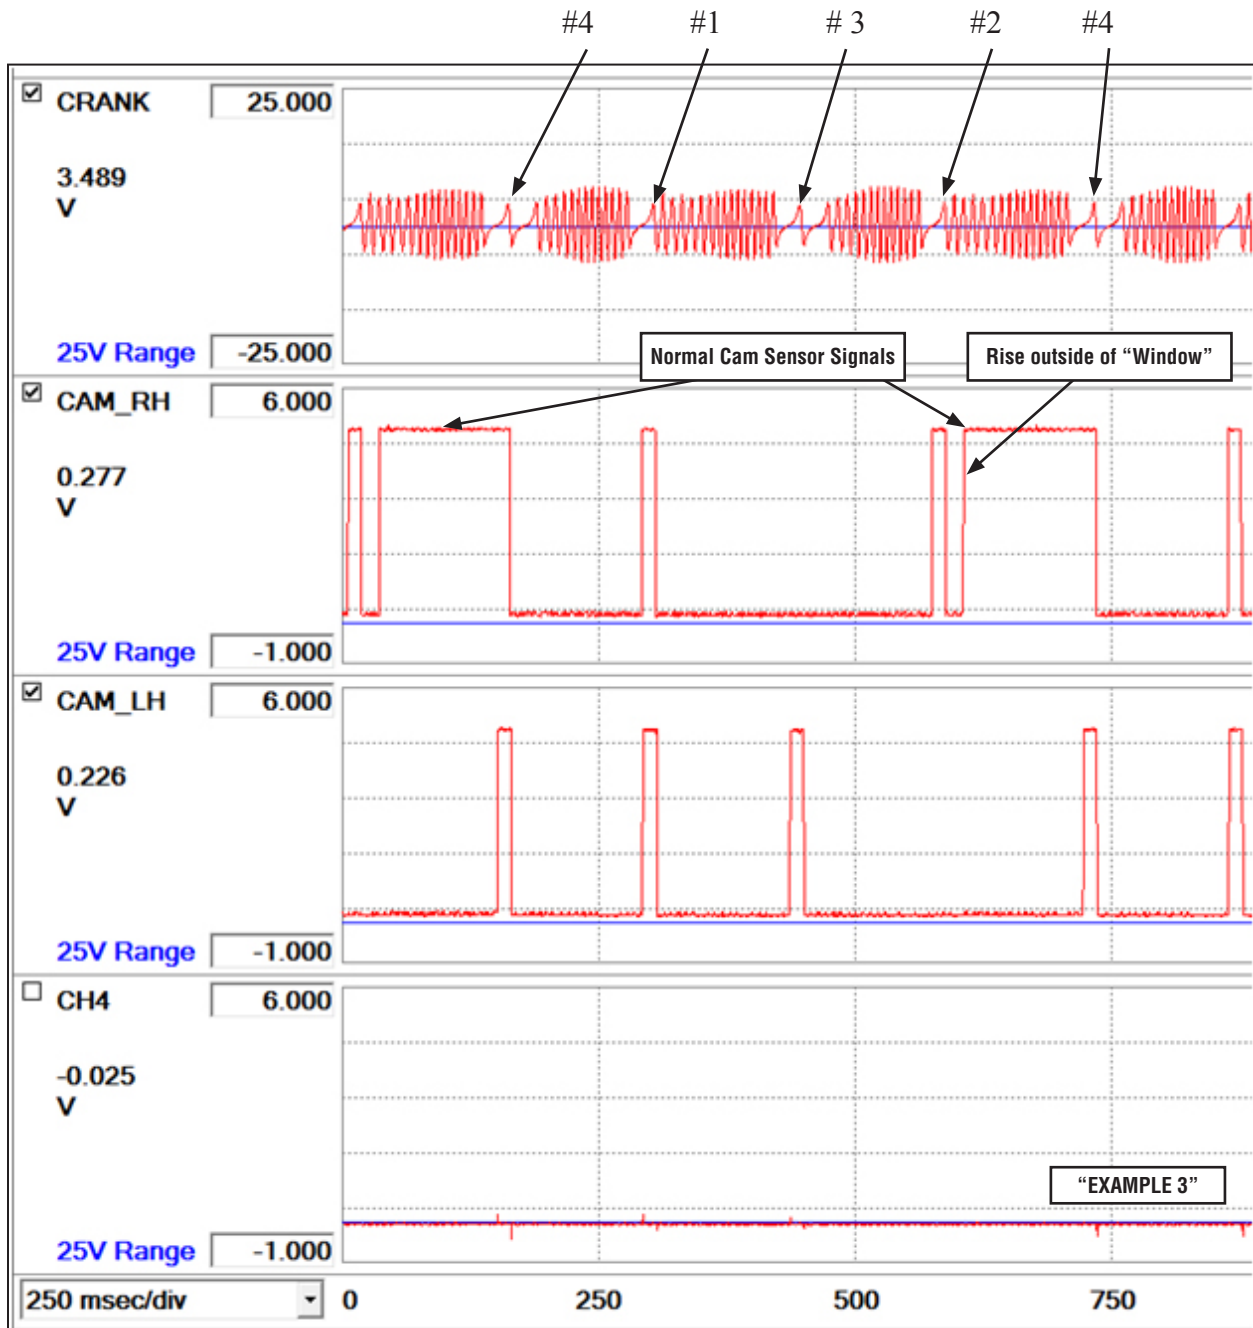
**Example 3** shows what *appears* to be an erratic signal from the RH cam sensor but, you can see all the cam sensor data signal edges (drops) follow the chart and firing order as they are supposed to. Other signal edges (rises or drops) outside the “window” or a longer time line as shown here prior to the #4 signal edges seen on the RH cam sensor pattern are examples of signals which will be “ignored” by the ECM and are not a cause for concern.

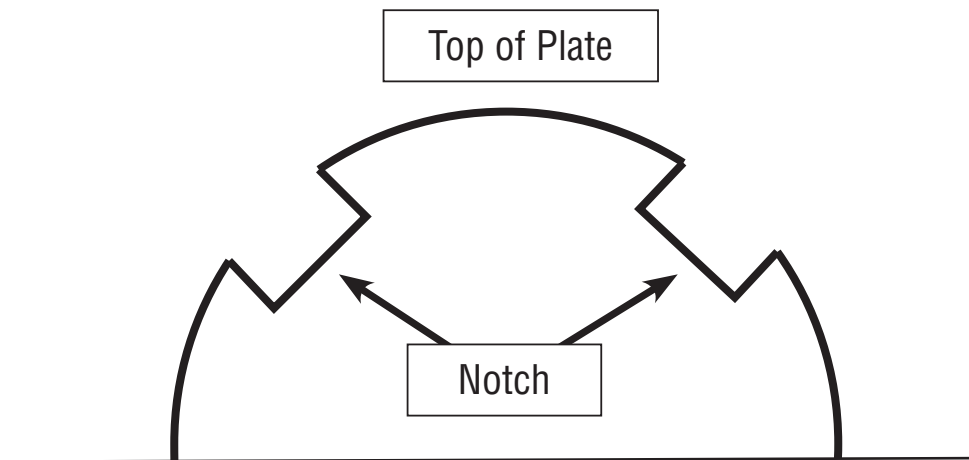
**NOTE:** When measuring “A”, make sure you are measuring to the outside diameter or “top” of the sensor plate and not to the bottom of a notch as shown below. Be sure to record all measurements.

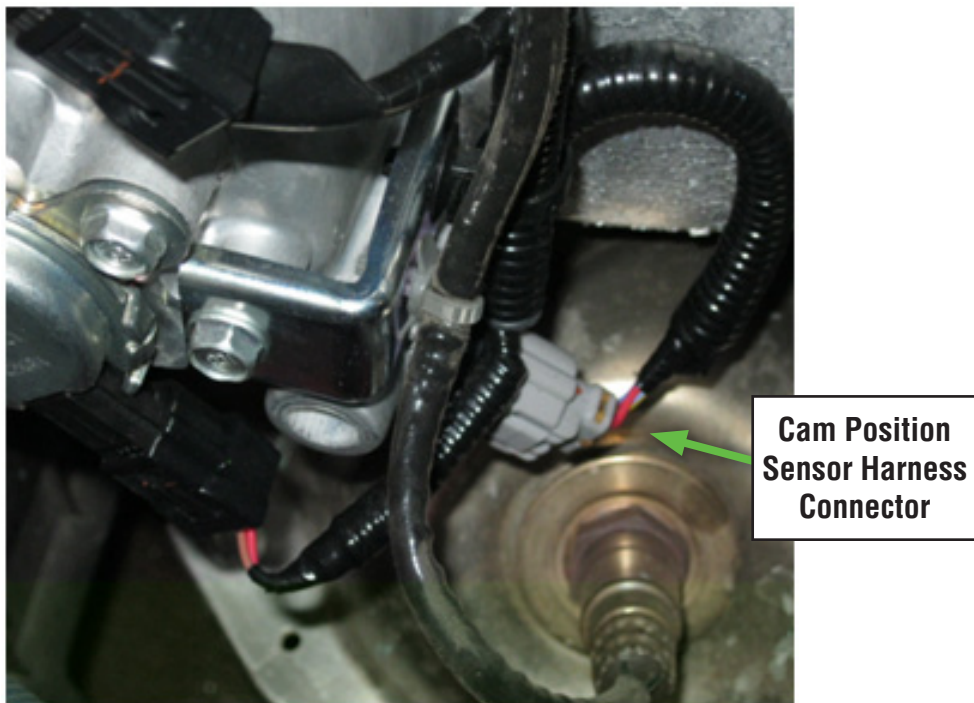
In the event you have a DTC stored for an exhaust camshaft position sensor, the repair procedure has been revised. Due to the position of the right-hand (Bank 1) sensor, measurement of the gap without removing the front catalyst is extremely difficult as shown in the photo below.

In addition, the engine under-guards must be removed along with the plastic splash shield to access the left-hand (Bank 2) sensor. As a solution, the following procedure has been developed:

1. Confirm the irregular oscilloscope pattern for the corresponding DTC stored.
2. Remove the sensor from the timing cover and install a .2mm thick shim from the applicable kit.
3. Reinstall the sensor, torque the sensor retaining bolt to 6.4 Nm (4.7 ft. lbs. or 56.4 inch-pounds) then recheck the oscilloscope pattern.

If the pattern is normal, the repair is complete. If the irregular pattern persists, repeat Steps 2 and 3 after removing the .2mm shim and installing a .3 mm thick shim. **ONE SHIM ONLY, NO STACKING.** Repeat as necessary increasing the shim thickness .1 mm at a time until a normal scope pattern can be verified.
