Service Bulletin

Bulletin No.: 09-08-110-011C

Subject: Front or Rear Door Lock Lever Bezel Loose or Detached (Replace Bezel)

Models: 2008-2011 Cadillac CTS, CTS-V

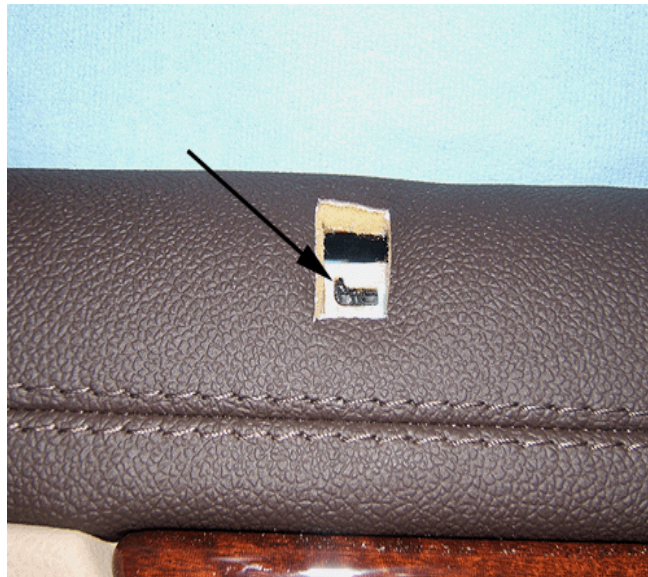
2260526

Some customers may comment that the trim (bezel) around the manual lock lever located on the door panel near the window is loose or has become detached.

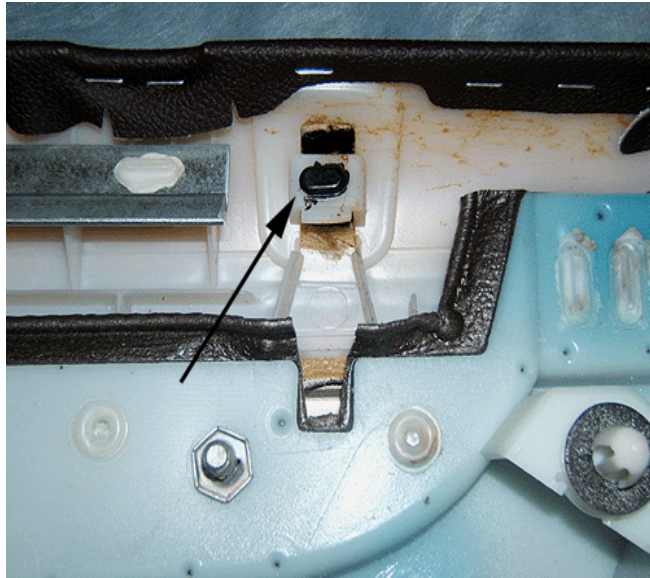
2260527

This condition may be caused by a weakening of the heat stake tab fastening the bezel to the trim panel.
