Service Bulletin

Bulletin No.: 10-08-42-001D

Subject: Low Beam Headlamp Bulb Diagnosis/Replacement (Inspect Bulb and Connector)

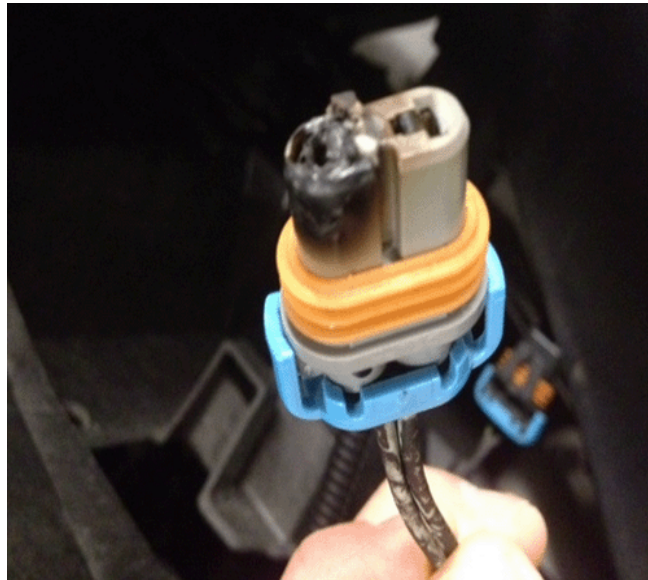
3991128

- If the connector is discolored at the bulb interface, replace the connector (service pigtail listed below) and bulb.
3. Cut the wires of the connector approximately 45 mm (1¾ in) from the connector and splice in the service pigtail connector. Ensure that the splices are not above the connector when re-installing.
