<b>HYUNDAI</b>   NEW THINKING. NEW POSSIBILITIES.  <b>Technical Service Bulletin</b>	GROUP	NUMBER
	<b>AUTOMATIC TRANSMISSION</b>	<b>13-AT-013-1</b>
	DATE	MODEL
	<b>NOVEMBER 2013</b>	Tucson (LM), Santa Fe (CM/AN/NC), Sonata (YF/YF HEV), Elantra (UD/MD/GD/JK), Accent (RB), Azera (TG/HG), Veloster (FS)
<b>SUBJECT:</b>	<b>AUTOMATIC TRANSAXLE (6-SPEED) INHIBITOR SWITCH DTC P0705, P0706, P0707 &amp; P0708</b>

***This TSB supersedes TSB 13-AT-013 to revise the Description and Parts Information.***

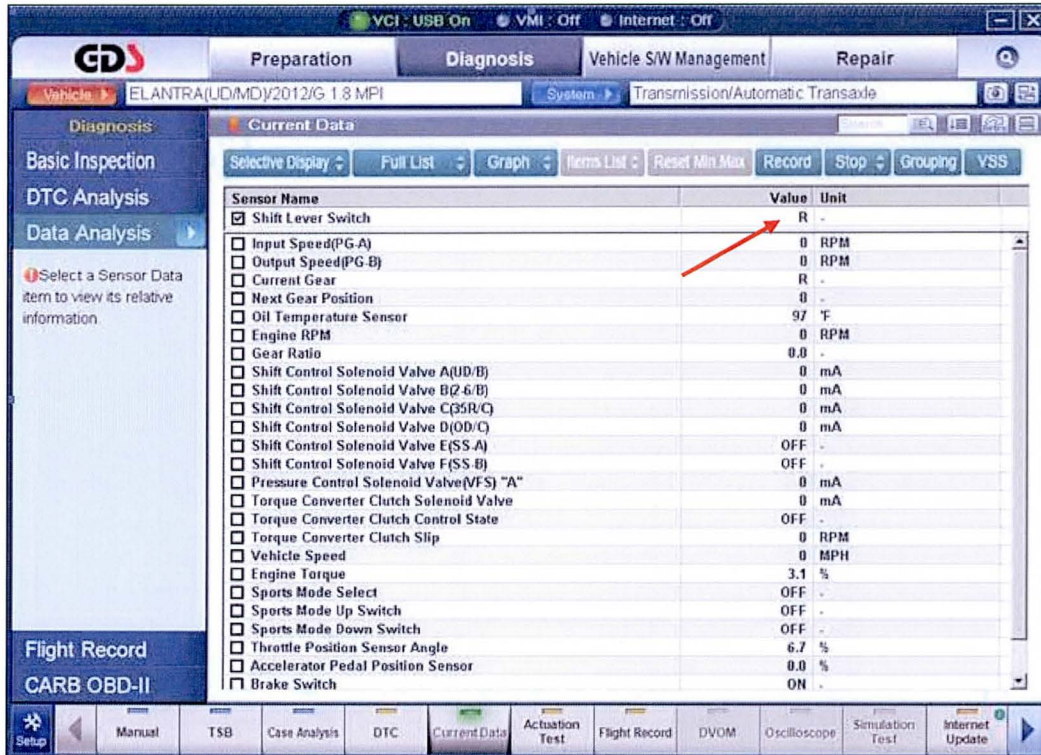
1. Turn the ignition key to the ON position or push the Start/Stop Button two times.
2. Using a GDS, check for DTC in the “Automatic Transaxle” menu. **Record the DTC and description.** Delete the DTC.
3. Select the following parameters. Move the shift lever through all gears and monitor the sensors.
  - Vehicle and A/T menu.
  - “Current Data”
  - Shift Lever Switch.
