Technical Service Bulletin

GROUP	NUMBER
ENGINE	14-EM-003
DATE	MODEL(S)
JUNE, 2014	MULTIPLE MODELS

SUBJECT: OIL PUMP MODULE TIMING MARK CONFIRMATION

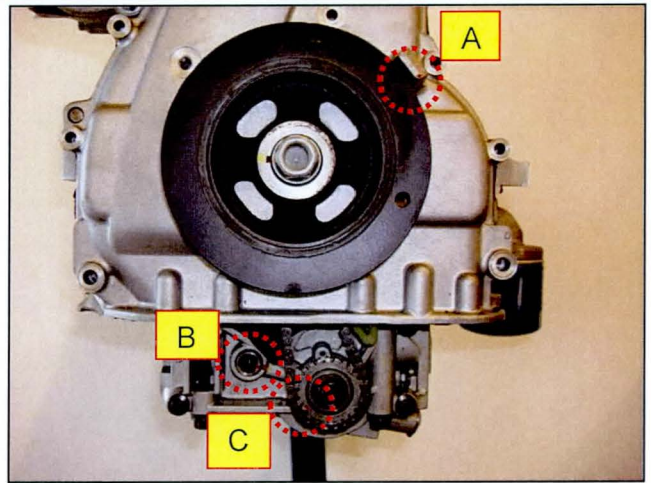
1. Prior to installing the lower oil pan, confirm the proper indexing of the Oil Pump Module timing marks.
Locate the timing marks for (A) crankshaft pulley and timing chain cover, (B) counter balance driven shaft and housing, (C) oil pump driven sprocket and housing.
