Technical Service Bulletin

21 MIL on (DTC P02900 - wastegate linkage disconnected)

21 14 20 2039006/1 November 17, 2014.

Model(s)	Year	VIN Range	Vehicle-Specific Equipment
A4, A5, A5 Cabriolet, A6, Q5, TT	2013 - 2014	All	2.0 TFSI

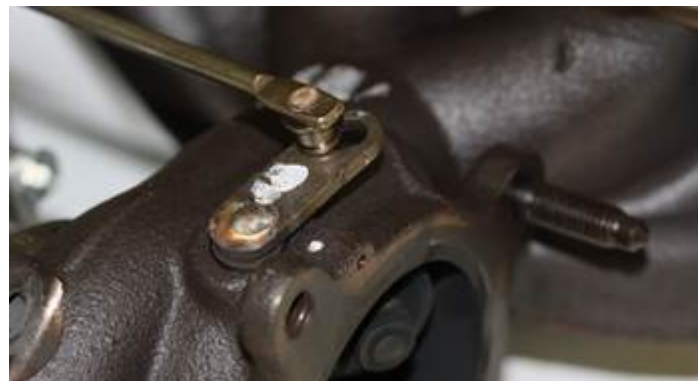
The circlip connecting the turbo wastegate actuator rod and the wastegate flap lever can fall off due to low tension of the clip. Consequently, the wastegate linkage becomes disconnected, causing MIL on and DTC P029900.

Figure 1. Disconnected wastegate linkage.

2. Remove catalyst according to ELSA instructions to gain access to turbocharger wastegate linkage.
3. Reconnect wastegate linkage and secure with a new circlip (separately available in ETKA).
