Service Bulletin

Bulletin No.: 12-08-64-004A

Subject: Front Door Window Jamming Half Way - Glass Falling Out of Front Run Channel

Models: 2011-2014 Chevrolet Caprice PPV
2014 Chevrolet SS
2008-2009 Pontiac G8

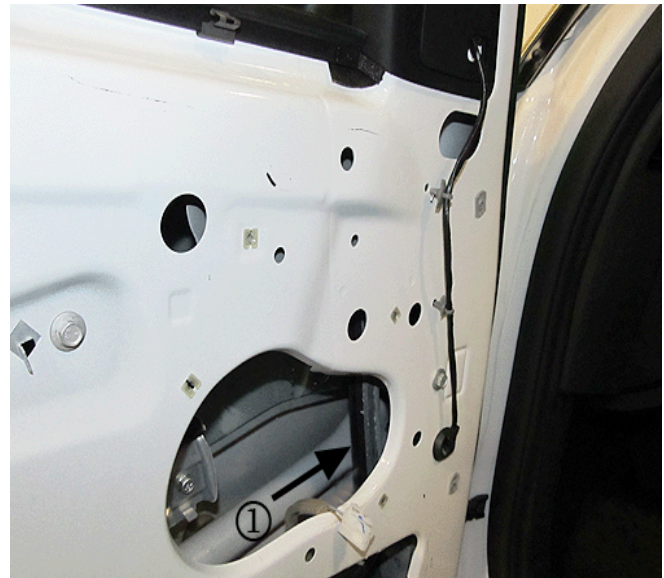
2890866

The cause of this condition may be the front edge of the door glass has become dislodged from the front window run channel and seal. This usually occurs when the front door has been slammed with the window in the fully lowered position.

1. Remove the front window run channel (1) on the affected door. Refer to Front Side Door Window Front Channel and Rear Channel Replacement in SI.
