# Service Bulletin

Bulletin No.: 14-06-04-005

**Subject:** Duramax® Diesel Glow Plugs Difficult to Install Due to Carbon Buildup - New Glow Plug Bore Reamer Available

**Models:** 2001-2010 Chevrolet Kodiak  
2001-2015 Chevrolet Express, Silverado 2500/3500  
2001-2009 GMC Topkick  
2001-2015 GMC Savana, Sierra 2500/3500  
Equipped with Diesel Engine RPOs LB7, LLY, LMM, LGH or LML

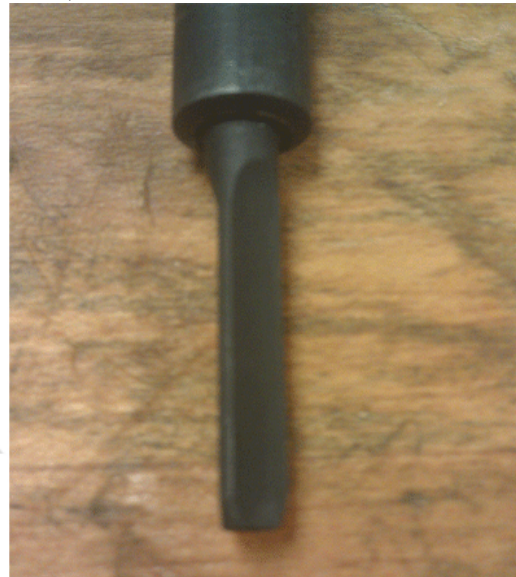
3955272

Technicians may find that glow plug installation is difficult due to carbon building up in the bore.

Carbon may build up around the glow plug tip during normal engine operation and cause difficulty with the installation of a new glow plug.

EN-51249 Glow Plug Bore Reamer is now available for removing carbon. It is non-threaded so that it can work on multiple model years.
