# Program Bulletin

## CUSTOMER SATISFACTION PROGRAM

**SUBJECT:** Rear Axle Grinding Noise, Vibration - Inspect Rear Axle

**MODELS:** 2011-2012 Chevrolet Express  
2011-2012 Chevrolet Silverado, Suburban 2500 Series  
2011-2012 GMC Savana  
2011-2012 GMC Sierra, Yukon XL 2500 Series  
Equipped with a 10.5" Rear Axle

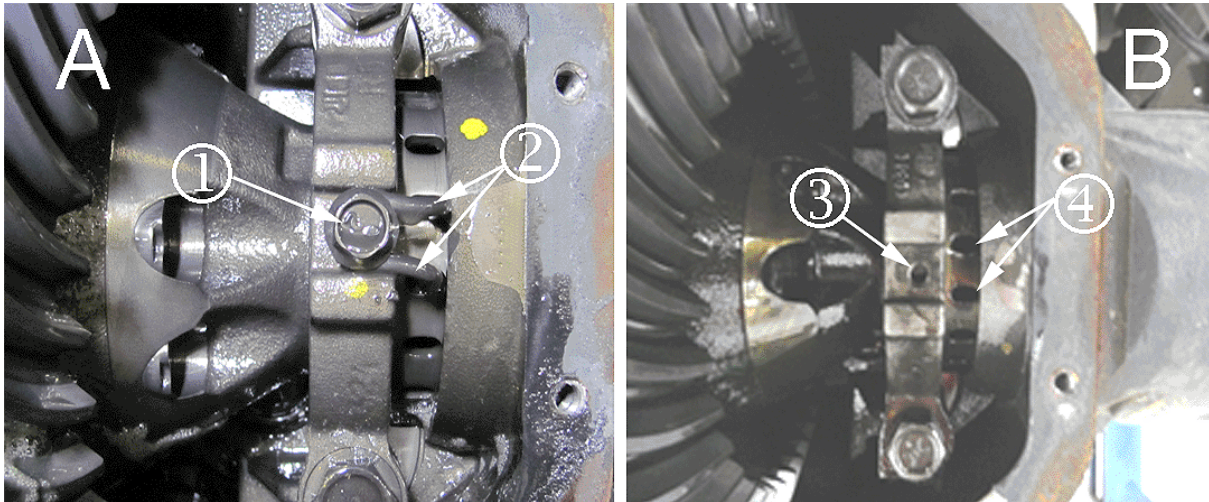
2790899

**Adjuster Bolt (1) and (2) Clip Present. (B) Adjuster Bolt and Clip Not Present (3) and (4).**

10. Determine if the passenger side (right) adjuster bolt (1) and clip (2) are present.
  - If the passenger side adjuster bolt and clip are present (A), remove the adjuster bolt and clip. Discard only the clip. Refer to illustration. Proceed to Step 11.

- If the passenger side adjuster bolt and clip are NOT present (B), replace the drive pinion, ring gear, differential side bearings, adjuster bolt and adjuster clip. Refer to *Differential Replacement (10.5 Inch Axle)* in SI. Proceed to Step 14 after replacing the drive pinion, ring gear, pinion bearings and differential side bearings. Refer to illustration.

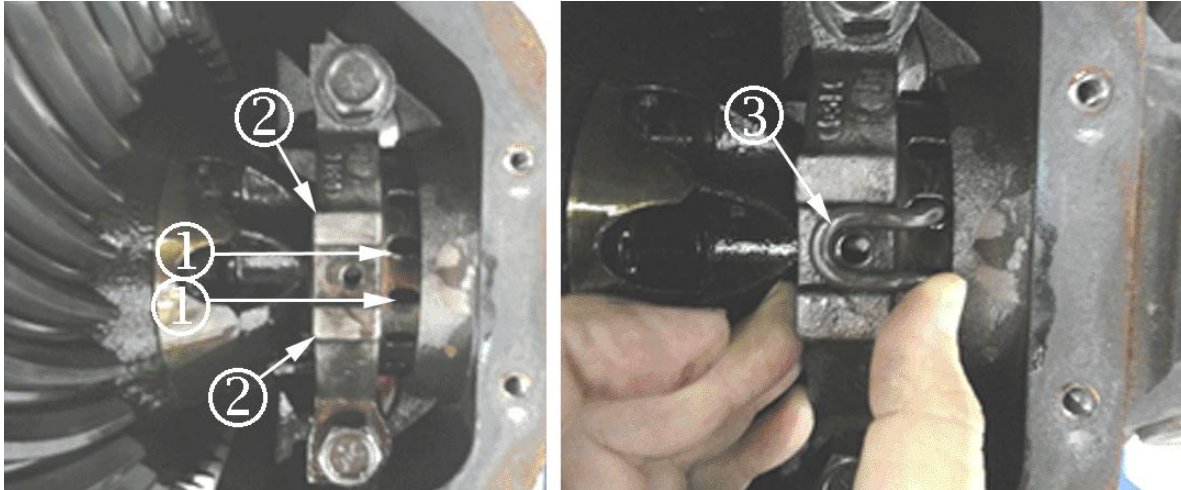
2790908

Visually inspect the adjuster nut slot alignment (1) and then use a new adjuster clip (3) to verify slot alignment. The adjuster clip (3) must be seated between the cap bolt ribs (2) and into the adjuster nut holes as shown in illustration.

11. Inspect the adjuster nut slot location in reference to the cap bolt ribs (2).

- If the adjuster nut slots are aligned (1) as shown in illustration, no adjustment is required. Proceed to Step 13.
- If the adjuster nut slots do NOT align, proceed to Step 12.

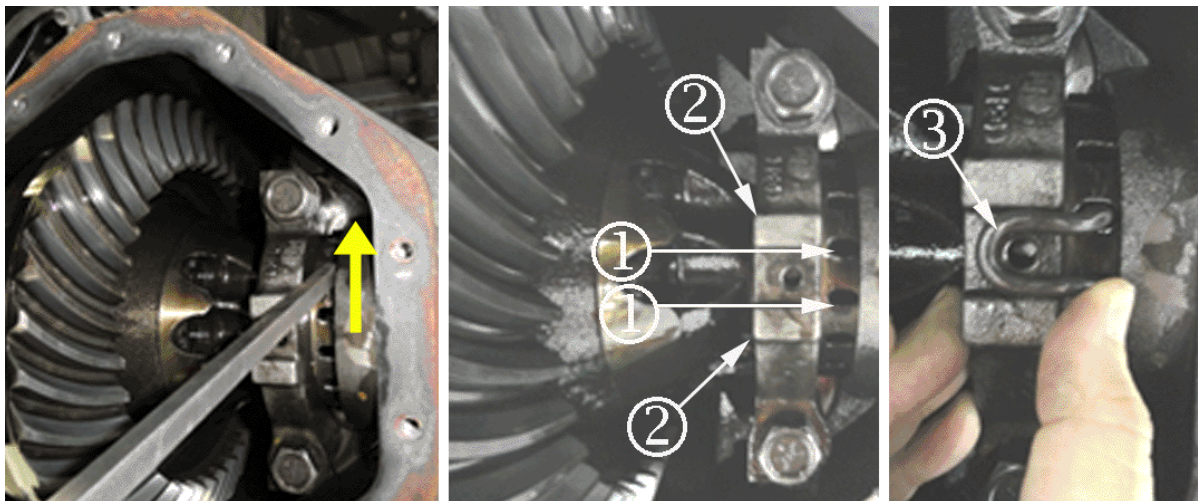
2790914

**Caution:** If indexing the adjuster is required, the adjustment direction is critical. The passenger side adjuster **MUST** be rotated in an upper direction to the nearest slot. If an upper direction is **NOT** used, bearing preload is lost.

- Using J-24429 spanner (or equivalent) in the adjuster nut slot (1), rotate the adjuster nut enough to center the clip between the cap bolt ribs. Only rotate the adjuster nut in an upward direction.

- Use a new adjuster clip (3) to verify alignment. The adjuster clip (3) must be seated between the cap bolt ribs (2) and into the adjuster nut slots as shown in illustration.
