# Recall Bulletin

## PRODUCT SAFETY RECALL

**SUBJECT:** Driver Door Switch Short Circuit

**MODELS:** 2006-2007 Buick Rainier  
2006 Chevrolet TrailBlazer EXT  
2006-2007 Chevrolet TrailBlazer  
2006 GMC Envoy XL  
2006-2007 GMC Envoy  
2005-2007 Saab 9-7X

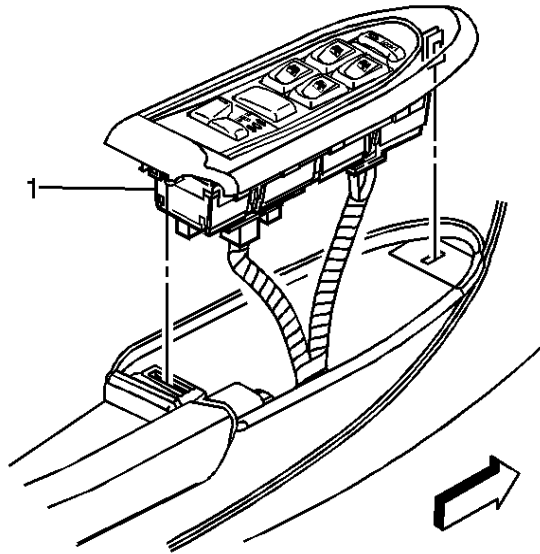
690976

1. Remove the driver side door lock and side window switch. Refer to *Door Lock and Side Window Switch Replacement - Driver Side* in SI.

2. Determine the part number on the driver side door lock and side window switch. The part number is on the side of the switch on the label.
  - If the part number on the switch is listed on the table above, no repair is required. Re-install the driver side door lock and side window switch. Refer to *Door Lock and Side Window Switch Replacement - Driver Side* in SI.
  - If the part number on the switch is NOT listed on the table above, replace the driver side door lock and side window switch. Refer to *Door Lock and Side Window Switch Replacement – Driver Side* in SI. .
