# Technical Service Bulletin

## 57 Remote key memory not active

57 14 01 2031413/2 May 1, 2014. Supersedes Technical Service Bulletin Group 57 number 12-78 dated October 26, 2012 for reasons listed below.

Model(s)	Year	VIN Range	Vehicle-Specific Equipment
A6	2005 - 2011	All	Not Applicable
Q7	2007 - 2015	All	Not Applicable

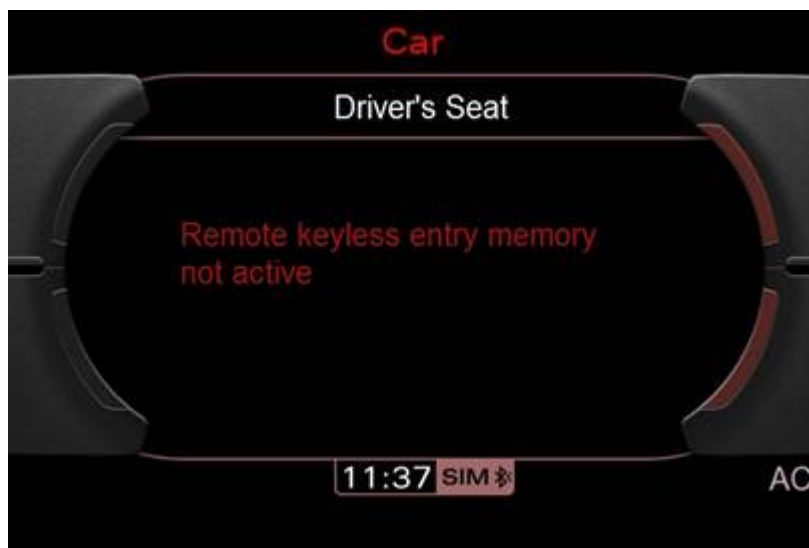
- The seat memory does not work.
- The MMI displays a message that the memory function is not active (Figure 1).

**Figure 1.** MMI message. The exact message may vary from the message pictured here.

The seat memory control unit can be deactivated due to voltage fluctuations in the vehicle's power system, or from a large static discharge through the seat cover. If the seat memory control unit is deactivated due to either of these influences, the control unit cannot be reactivated through any vehicle controls, vehicle keys, or through the normal GFF test plans. It can only be reactivated with special test plans within the tester.
