# Technical Service Bulletin

## 94 Headlight flickers, flickering, or warning on in cluster (all xenon headlights)

94 14 36 2029194/5 April 2, 2014. Supersedes Technical Service Bulletin Group 94 number 13-10 dated March 4, 2013 for reasons listed below.

Model(s)	Year	VIN Range	Vehicle-Specific Equipment
Q7	2010 - 2015	All	Premium Plus and Prestige

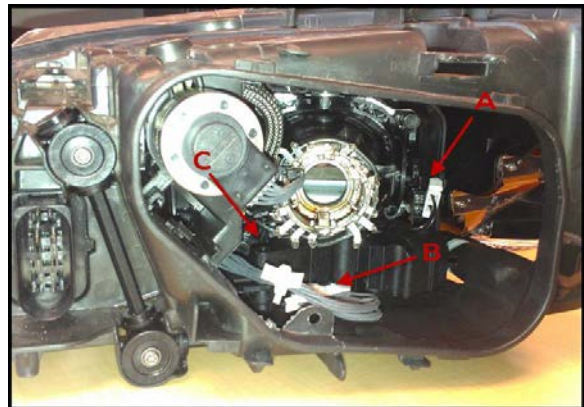
3. Remove the covers from the back of the headlamp housing. Check all of the connectors inside of the headlamp housing (Figure 1) for proper seating and inspect the locks to ensure that they are fully engaged:

**Figure 1.** Back of a tri-xenon headlamp showing three connectors (A, B, and C). A bi-xenon headlamp will only have a single connector (A).

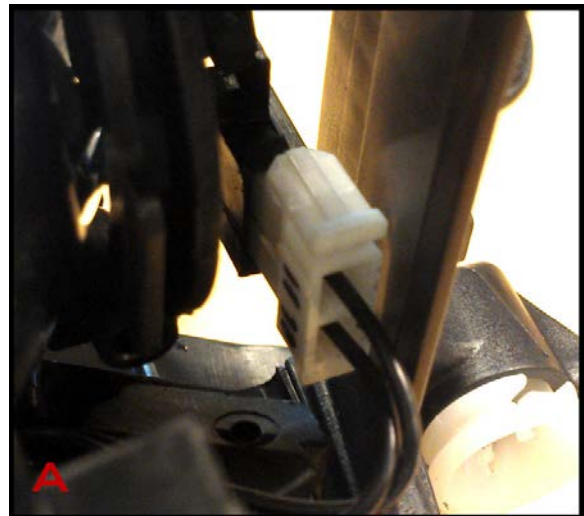
One or more of the connectors inside the headlamp housing are disconnected fully or partially from the factory.

**Figure 2.** Connector “A” shown not fully seated.

- Connector “A” can be seated, but not fully engaged (Figure 2). It is important to hold the projector housing when this connector is pushed, otherwise, the projector will swivel.
- Connector “B” can be fully locked into place, but be rotated 5-10 degrees off-center (Figure 3). Ensure that the harness connector is seated parallel to the connector housing on the headlamp.
- Connector “C” (Figure 4) is located behind the motor mechanism, which rests below the projector lens. It is a very small two-pin connector that should be adjusted cautiously. If it becomes fully disconnected, it is very difficult to re-connect without the use of special tools. Use your finger or a small set of bent pliers to pull the connector toward you in order to fully seat it.

4.
  - If no loose connectors were found and the issue still persists, the issue is outside the scope of bulletin. Do not proceed with the bulletin. Continue with diagnosis by swapping headlamp components to locate the failed part.
  - If a loose connector was found, correct it and ensure that all connectors are fully seated and locked.
- 5 Re-assemble the headlamp and re-install it into the vehicle.
6. Clear the DTC(s) and re-test with the low beams, high beams, and all turn signals activated.
7. If the DTCs do not return, test the headlamp functionality with a short road test:
  - Repeat the actuation of all headlamps while the vehicle is moving.
  - If Audi adaptive light is equipped, test its functionality by driving the vehicle around a corner at a speed greater than 6 mph (Figure 5).

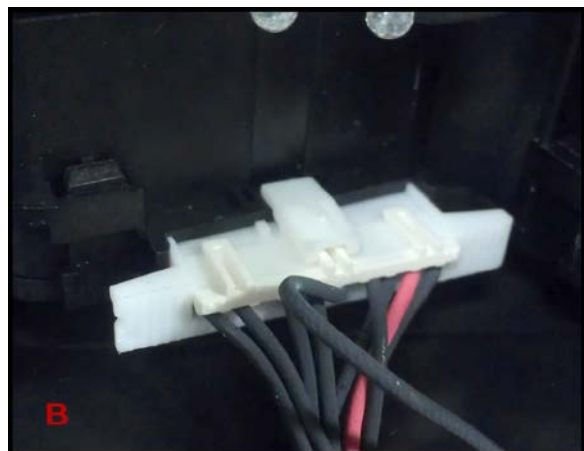
**Figure 3.** Connector “B” shown off-center.

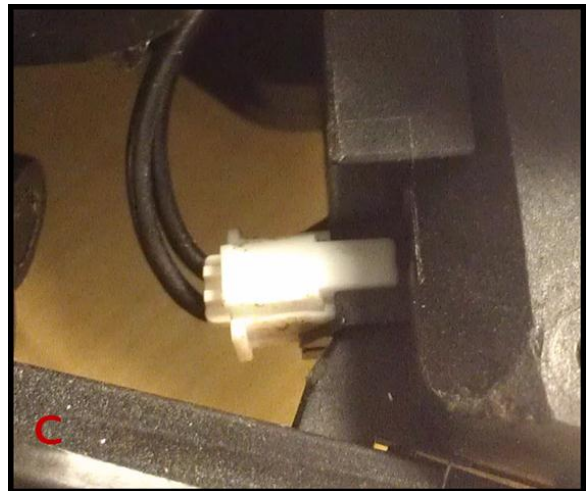
**Figure 4.** Connector “C” shown in the locked position.

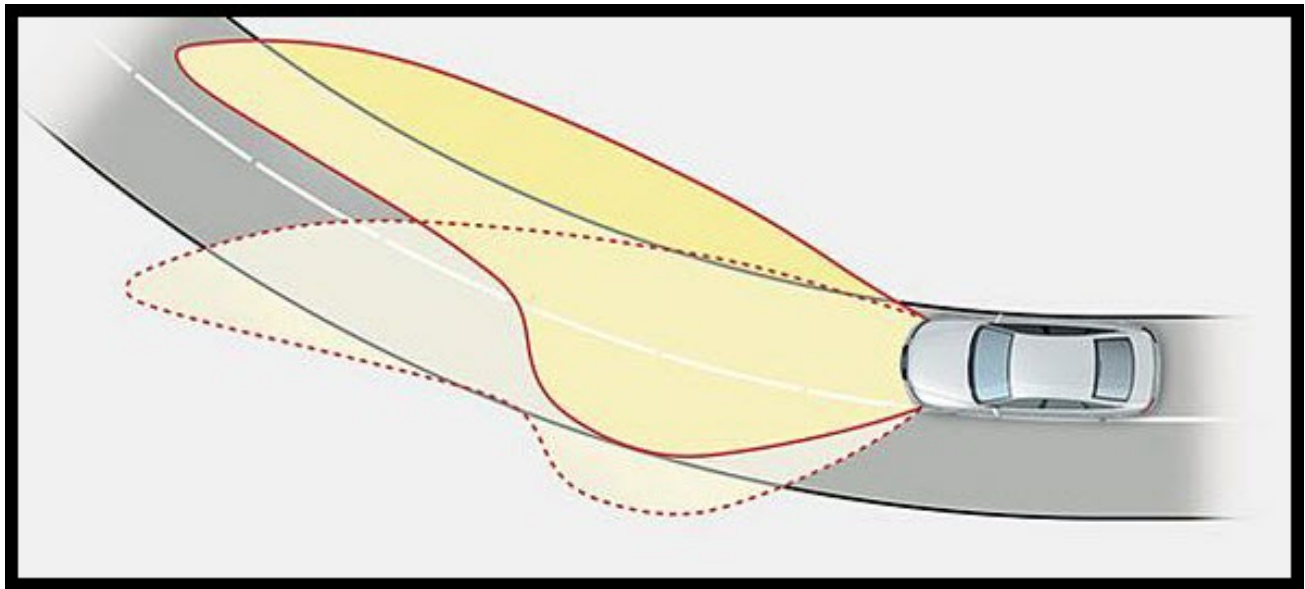
**Figure 5.** Audi adaptive light illustration showing the maximum 15° curve of the light beam at speeds greater than 6mph.
