# Technical Service Bulletin

## 94 Moisture accumulation in headlamps

94 14 44 2028277/11 June 26, 2014. Supersedes Technical Service Bulletin Group 94 number 13-30 dated December 20, 2013 for reasons listed below.

Model(s)	Year	VIN Range	Vehicle-Specific Equipment
Q7	2010 - 2014	All	Not Applicable

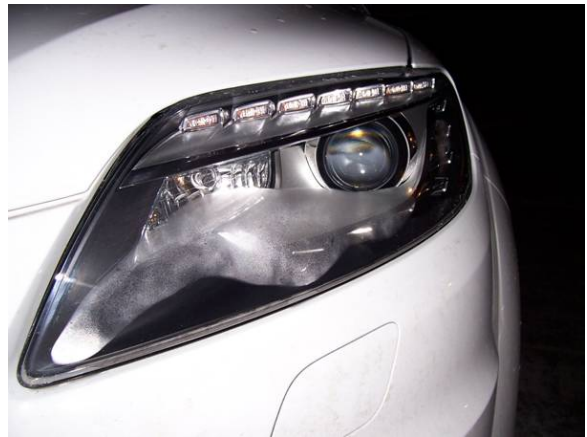
- There is considerable moisture present in the headlamp (Figure 1).
- The moisture disappears only after extended drives (greater than 10 minutes).
- There is no external damage to the headlamp which could introduce moisture.

*Figure 1. Moisture in headlamp.*

Humid air settles on the inside of the glass, causing moisture to appear on the inside of the headlamp lens.

When high air humidity and temperature differences exist between the inside of the headlamps and the outside, condensation can form on the inside of the lens, especially in cold and wet weather. This moisture buildup can happen, for example, after a car wash, after steam cleaning of the engine or the front end, or after overnight temperature changes.

1. Remove the headlamps and dry the inside using compressed air or a hot air blower. Check for any loose caps, loose or unsealed control modules, or cracks in the headlamp housing(s) as the source of moisture exposure.
2. Vehicles prior to VIN # \*CD004736 were not built with the updated ventilation hoses. If the updated

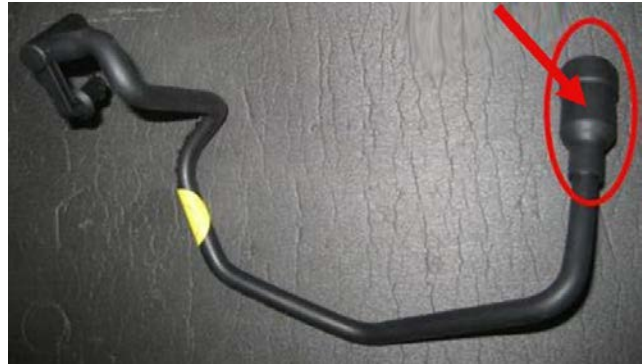
**Tip:** The updated ventilation hose can be recognized by the integrated filter (Figure 2, arrow).

**Figure 2.** Updated ventilation hose with integrated filter.

ventilation hoses are not currently installed, replace the headlamp ventilation hose for each headlamp with the new part number to help reduce any further humidity ingress into the headlamps (see *Required Parts and Tools*, below). Proceed to step 3.

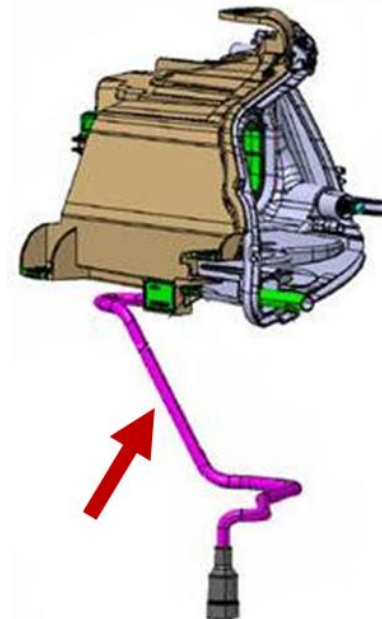
**Tip:** The updated ventilation hose is not connected directly to the headlamp housing. The hose routes downward from the headlamp carrier and between the radiator and bumper (Figure 3, arrow).

**Figure 3.** Mounting of updated ventilation hose.

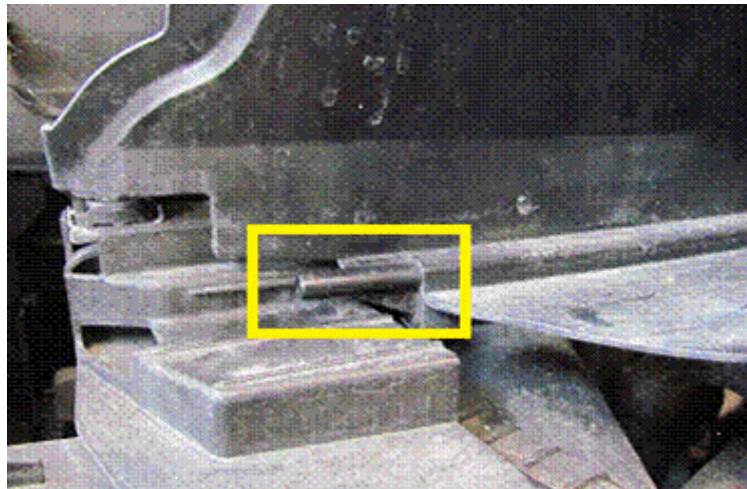
*Figure 4. Headlamp ventilation guide tube.*

3. Each headlamp air ventilation tube must be sealed to protect against further moisture ingress (Figure 4).

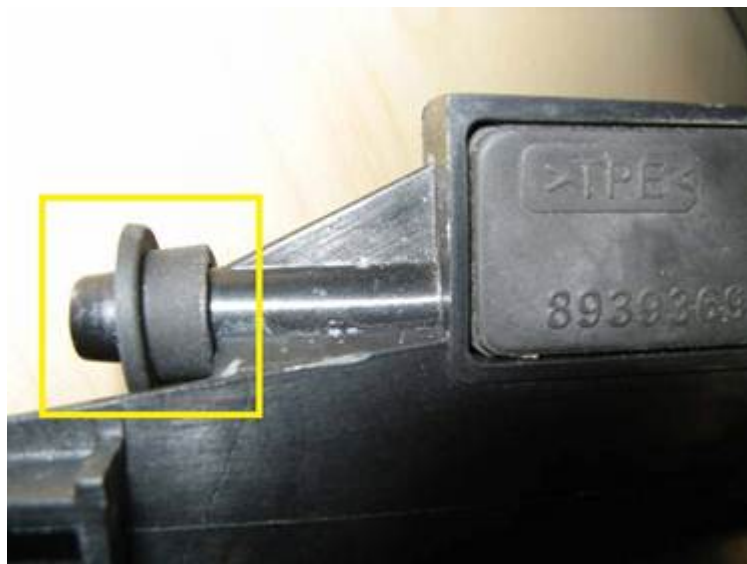
*Figure 5. Ring seal installed on headlamp air tube.*

4. Install ring seal on headlamp air ventilation tube (Figure 5). The larger diameter of the seal faces the headlamp.

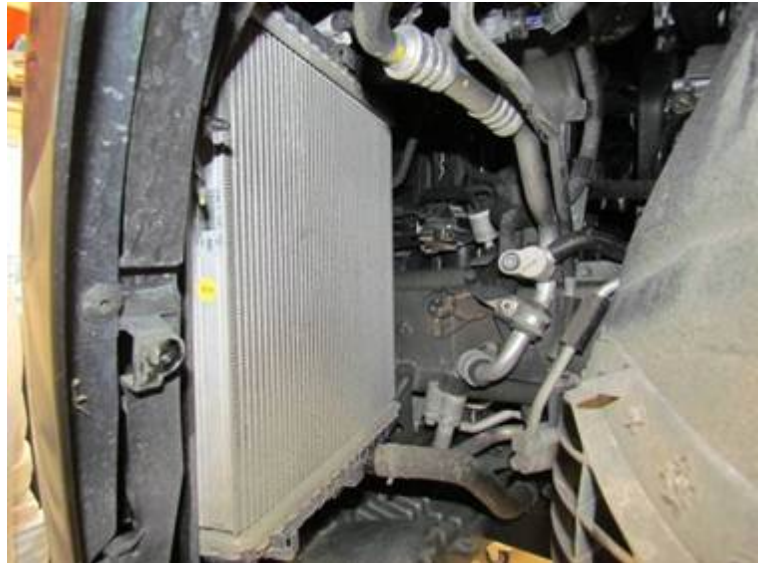
**Figure 6.** View of additional radiator with wheel well liner removed.

7. Remove front wheels and wheel housing liners. The rear of the charge air coolers or additional radiators will be exposed (Figure 6).

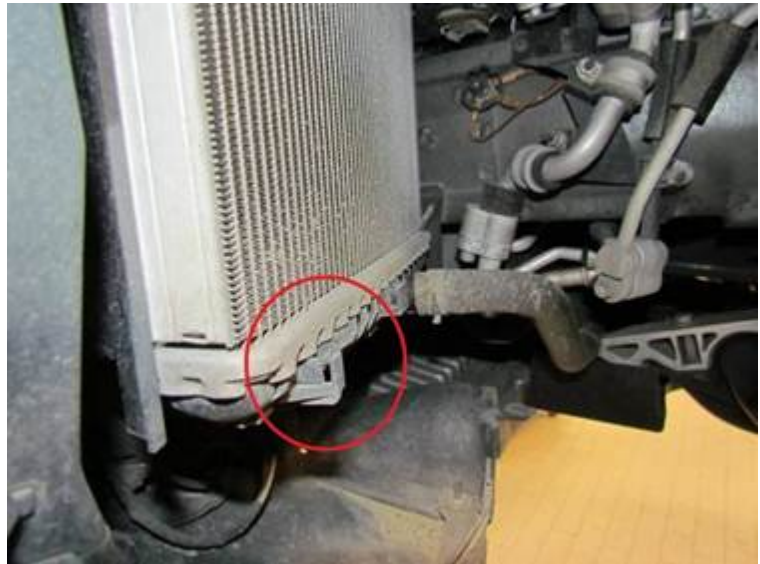
**Figure 7.** Lower exit air duct attachment point to additional radiator.

8. Locate exit air duct attachment hooks on the left and right charge air coolers or additional radiators (Figures 7 and 8).

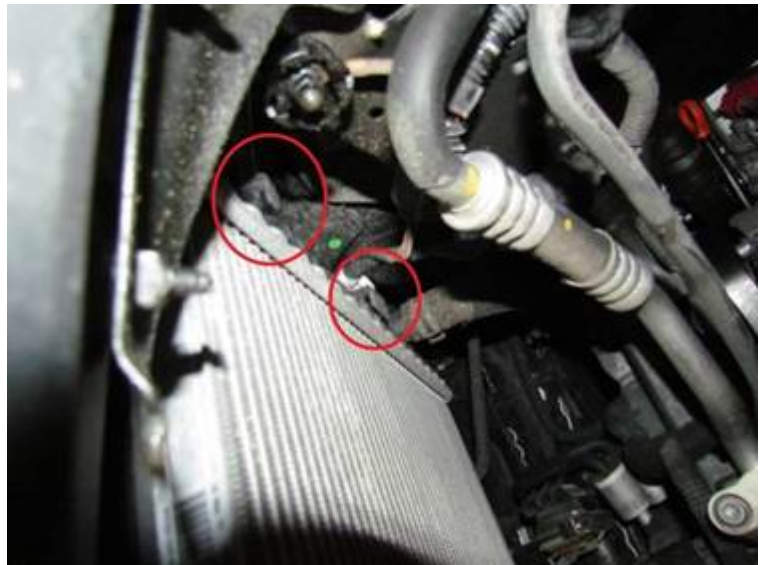
**Figure 8.** Upper exit air duct attachment points to additional radiator.

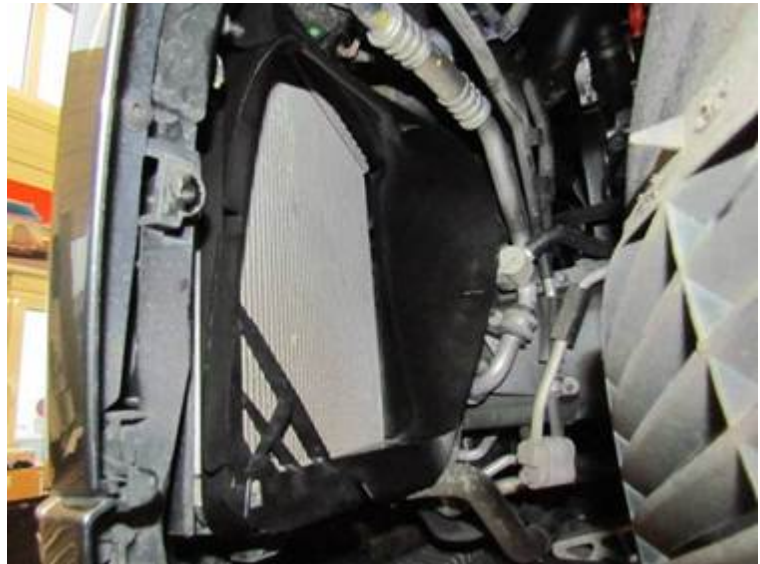
**Figure 9.** Exit air duct installed.

9. Affix left and right exit air ducts (Figure 9).

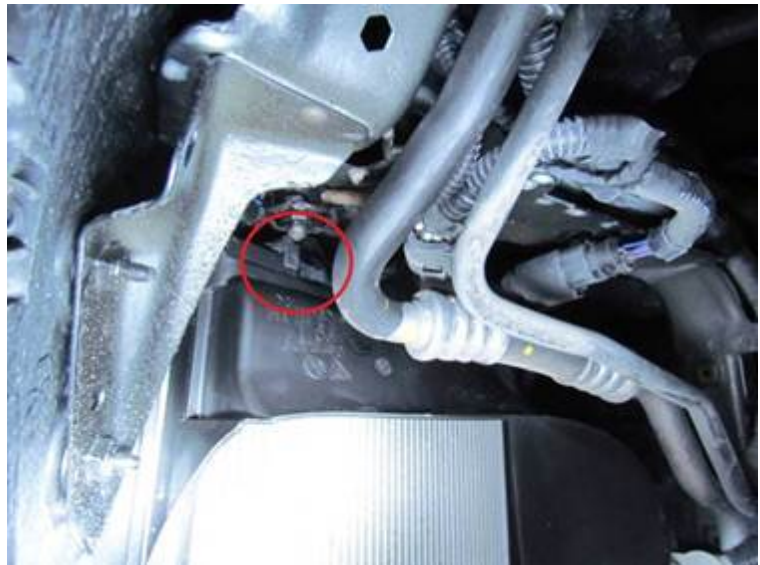
**Figure 10.** View of exit air duct affixed to mounting hook.

10. Inspect exit air duct attachment points to be sure that ducts are engaged properly over hooks (Figure 10).
