Technical Service Bulletin

94 High beam inoperative

94 14 58 2036670/2 December 10, 2014. Supersedes Technical Service Bulletin Group 94 number 14-34 dated March 7, 2014 for reasons listed below.

Model(s)	Year	VIN Range	Vehicle-Specific Equipment
Q5	2013 - 2016	All	Not Applicable

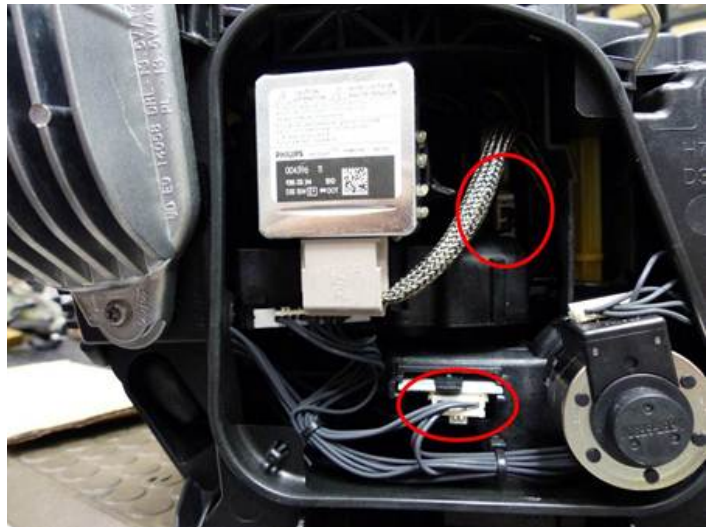
The connection for the high beam shutter is not connected in the affected headlight.

Figure 1. Connectors to be checked.

1. Remove the affected headlight and open the service cap.
2. Check the connectors (Figure 1) to see if they are securely connected.

3. If any connector is loose, inspect it for damage. If no damage is found, re-secure the connector. If it cannot be re-secured, replace the headlight.

When re-securing the connection, do not use a screwdriver or other metal object.
