Technical Service Bulletin

66 Wind noise from exterior rear view mirror base or at lane change assist lamp

66 13 34 2029586/6 September 30, 2013. Supersedes Technical Service Bulletin Group 66 number 13-32 dated September 26, 2013 for reasons listed below.

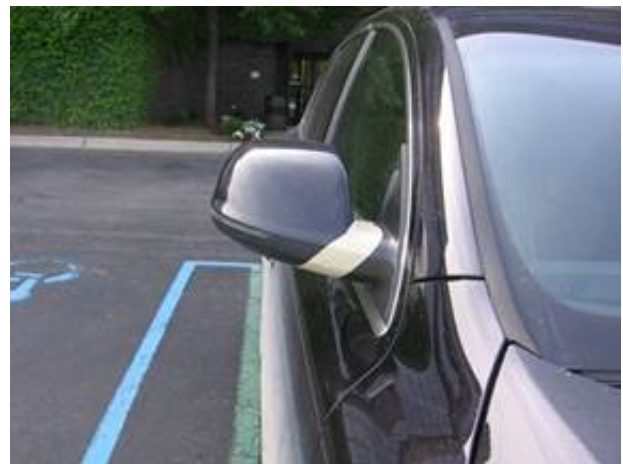
1. Apply tape to the seam at the rotation collar between the mirror mount assembly and the painted cover (Figure 1) to determine if the noise is coming from the mirror base.
 - If the mirror base is not the source of the noise, move to step 2.
 - If the mirror base is the source of the noise, replace the mirror base according to the ElsaWeb Repair manual: *Body >> Body Exterior >> 66 Exterior Equipment >> Removal and Installation >> Exterior rearview mirror >> Exterior rearview mirror.*

Figure 1. Tape applied to rotation collar seam.

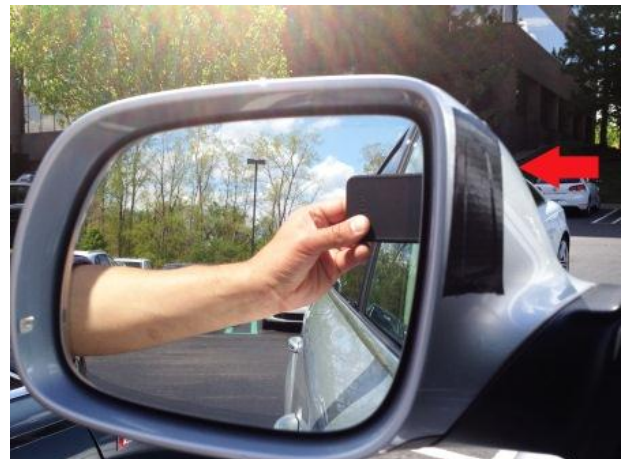
2. If the vehicle is equipped with lane change assist, remove the first piece of tape, then apply tape to cover the lane change assist marker lens (Figure 2) to determine if the lane change assist lamp is the source of the noise.
 - If the lane change assist lamp is the source of the noise, replace one or both of the lamps according to the ElsaWeb Repair manual: *Electrical System >> Electrical Equipment >> 96 Interior Lights, Switches >> Removal and Installation >> Lane Change Assistance >> Lane Change Assistance Warning Lamp in Exterior mirror.*

Figure 2. Tape applied over the lane change assist lens.
