Technical Service Bulletin

68 Noises from center console

68 13 10 2034517/1 July 15, 2013.

Model(s)	Year	VIN Range	Vehicle-Specific Equipment
TT	2010 - 2013	All	All

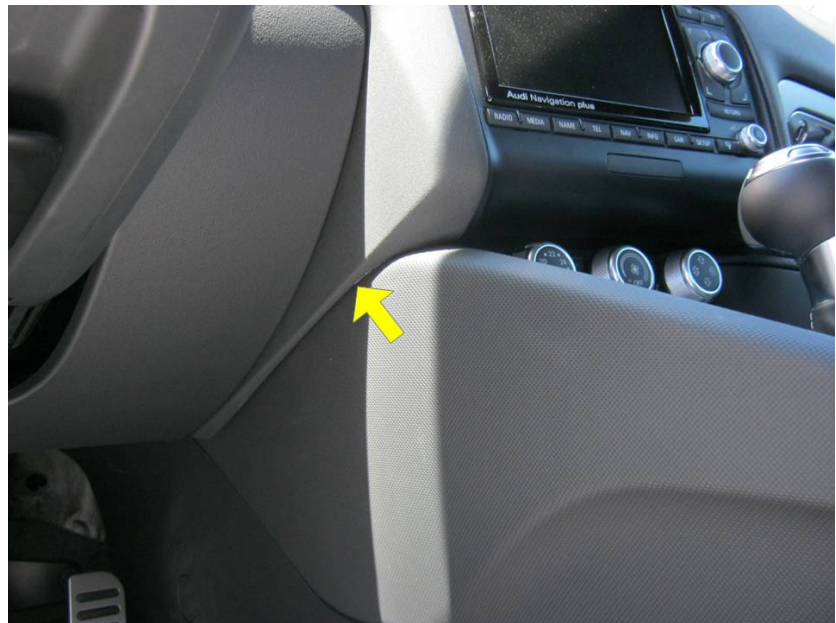
While driving the vehicle, the customer hears various noises coming from the center console area.

The noises are caused by too tight of a tolerance between the lower and upper portion of the center console (Figure 1).

Figure 1. No clearance between the upper and lower sections of the center console.

Adjust the console sections by following the instructions below. The objective is to eliminate the noise from this area by achieving a 1mm – 2mm clearance between the upper and lower sections of the center console:

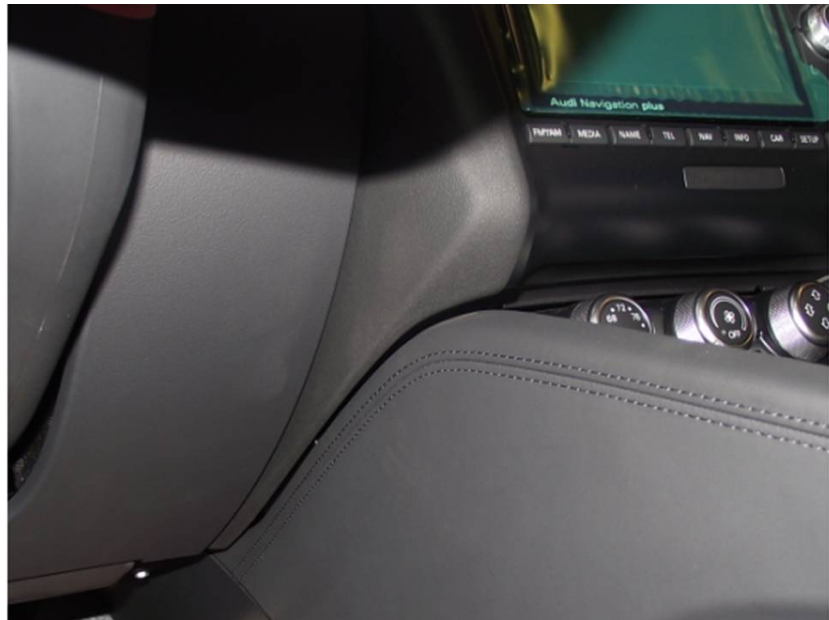
Figure 7. Gap achieved between the upper and lower sections of the center console after adjustment.

6. Reinstall the front center console. There should now be a gap of 1mm – 2mm between the upper and lower sections (Figure 7).
