# Technical Service Bulletin

## 70 Squeaks and rattles from the A-pillar area

70 13 32 2034381/1 July 9, 2013.

Model(s)	Year	VIN Range	Vehicle-Specific Equipment
TT	2012 - 2014	All	Not Applicable

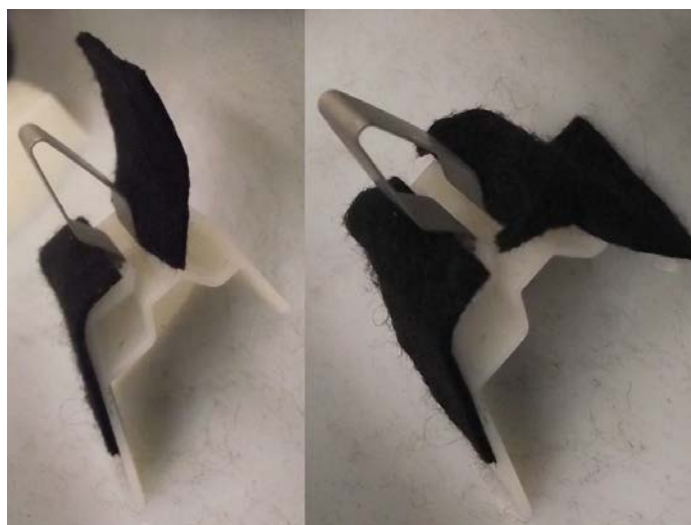
The openings in the reinforcement panel of the A-pillar structure are slightly off-center from the carrier plate. As a result, squeaking or rattling noises occur because the mounting clips for the A-pillar trim are either not fully engaged in the openings, or they are engaged and are unnecessarily tight against the edges of openings.

*Figure 1. Location of A-pillar trim where fleece tape is to be applied.*

1. Apply sections of fleece adhesive tape (**D 373125A2**) to the mounting areas of the A-pillar trim, as shown at right (Figure 1).

2. Install the A-pillar trim, ensuring that the clips are not damaged and that each one is fully engaged in the opening of the A-pillar structure.
3. Perform this repair to the A-pillar trim on both sides.
