Recall Bulletin

PRODUCT SAFETY RECALL

SUBJECT: Ignition Switch Replacement

MODELS: 2005-2007 Chevrolet Cobalt
2005-2006 Pontiac Pursuit (Canada Only)
2007 Pontiac G5

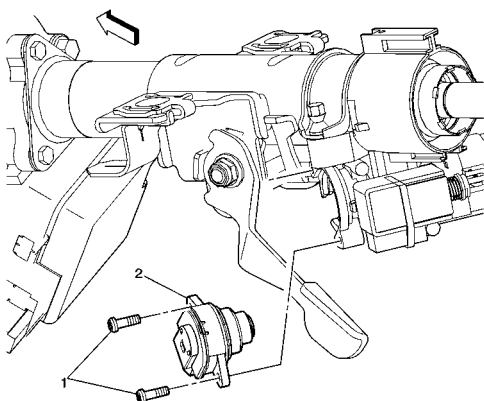
General Motors has decided that a defect which relates to motor vehicle safety exists in 2005-2007 model year (MY) Chevrolet Cobalt, 2005-2006 MY Pontiac Pursuit, and 2007 MY Pontiac G5 vehicles. There is a risk, under certain conditions, that the ignition switch may move out of the "run" position, resulting in a partial loss of electrical power and turning off the engine. This risk increases if the key ring is carrying added weight (such as more keys or the key fob) or the vehicle experiences rough road conditions or other jarring or impact related events. If the ignition switch is not in the run position, the air bags may not deploy if the vehicle is involved in a crash, increasing the risk of injury or fatality.

1. Remove the ignition switch from the vehicle. Refer to *Ignition and Start Switch Replacement* in SI.
2. Install a new ignition switch. Refer to *Ignition and Start Switch Replacement* in SI.
