Recall Bulletin

PRODUCT SAFETY RECALL

SUBJECT: Side Impact Airbag Connector

MODELS: Some 2008-2009 and all 2010-2013 Buick Enclave
Some 2009 and all 2010-2013 Chevrolet Traverse
Some 2008-2009 and all 2010-2013 GMC Acadia
Some 2008-2009 and all 2010 Saturn OUTLOOK

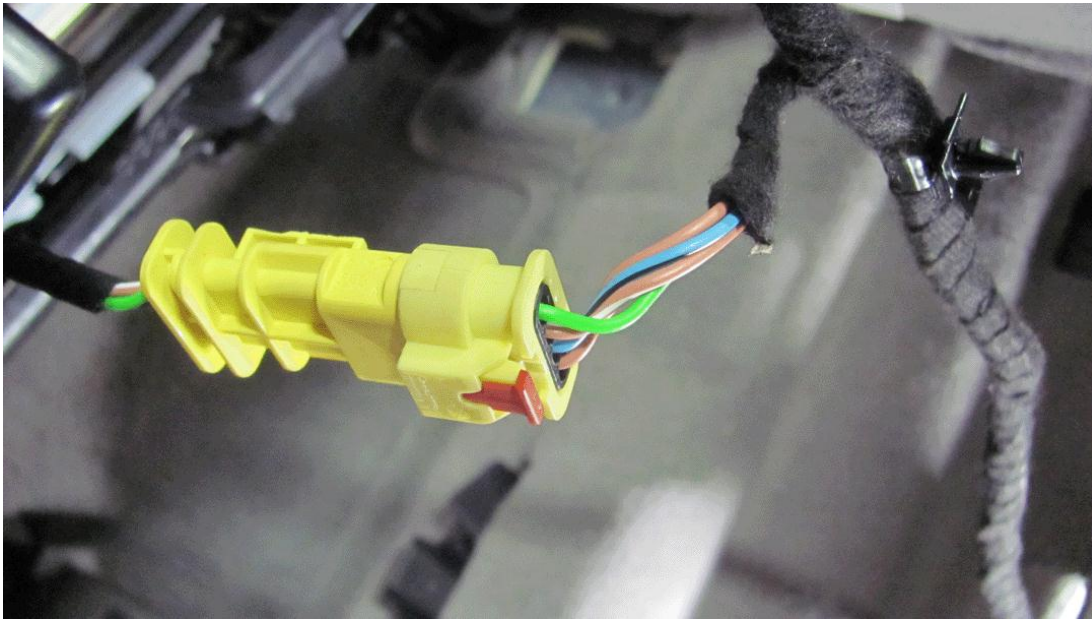
3714178

A yellow 4-way connector shown. The 2-way or 6-way yellow connector is similar.

3. Locate the yellow 2-way, 4-way, or 6-way connector under the seat.

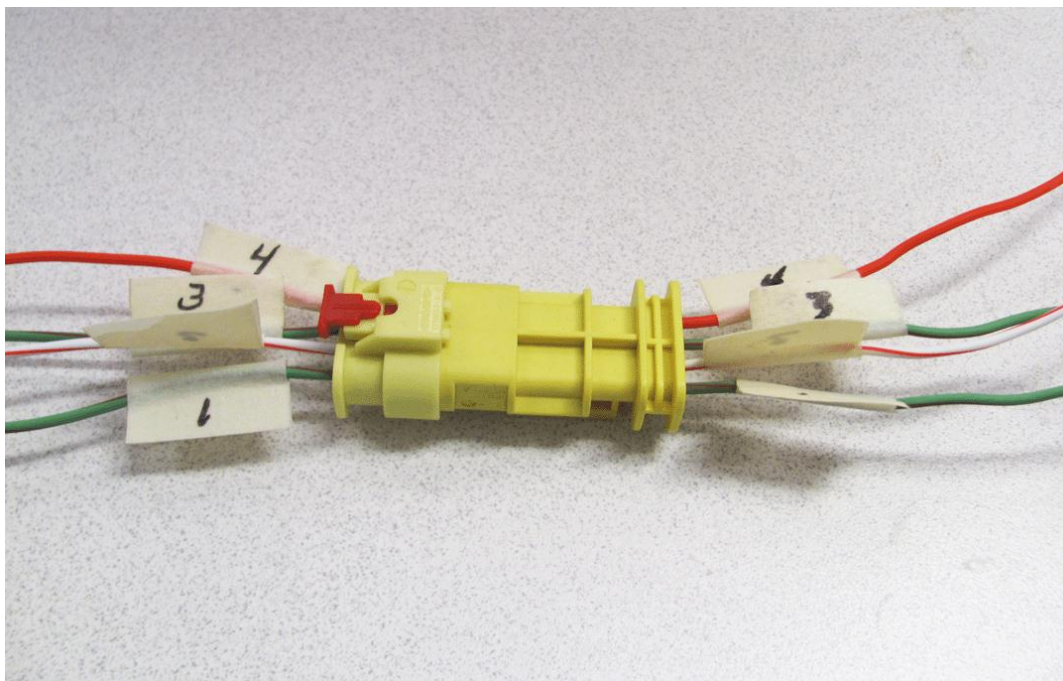
3782976

Four-way connector shown with wire harness out of vehicle for illustration purposes. It is critical that the wire pairs are identified correctly to avoid splicing incorrect wire pairs.

Note: Before removing the yellow connector from the seat and body harness, note the wire colors of the seat and body harness. Some wire pairs may be a slightly different color. Some wire pairs may have different colors. Ensure the wires are matched BEFORE splicing the wires of the seat and body harness together. Use the cutoff connector as a wire color template. BEFORE removing the connector from the harness, mark or identify wire pairs of similar color using a pen and tape to ensure the correct wires are spliced together. The first photograph shows a 4-way connector (1) and a 6-way connector (2).
