# Recall Bulletin

## PRODUCT SAFETY RECALL

**SUBJECT:** Electric Power Steering Assist

**MODELS:** 2009-2010 Chevrolet HHR (Non-Turbo)  
2010 Chevrolet Cobalt  
2004-2007 Saturn ION  
Equipped with Electric Power Steering

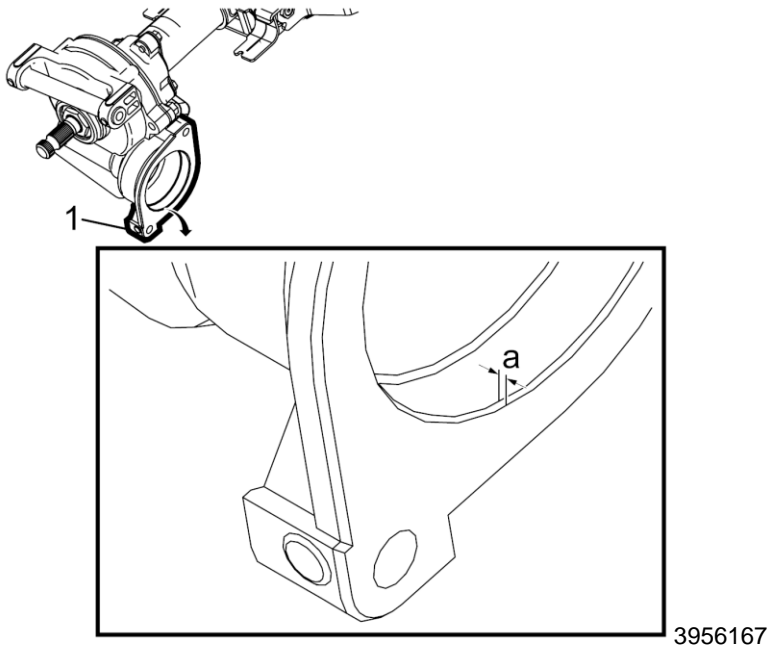
### **Power Steering Assist Motor Housing Inspection -- All Vehicles Except Chevrolet HHR**

**Caution:** First design steering motor with a small chamfer does not require a seal. If a seal is installed on a first design steering motor, potential damage to the steering motor may occur resulting in loss of assist steering. Seal is only required for the second design steering motor with the larger chamfer. Before installing the power steering assist motor, inspect the power steering assist motor housing (1) to verify the steering column design.

- **First Design:** If the chamfer (a) is **1 mm (0.04 in)** and **30 degrees** then the steering column is the first design and a power steering assist motor O-ring seal is NOT needed.
- **Second Design:** If the chamfer (a) is **2.7 mm (0.11 in)** and **45 degrees** then the steering column is the second design and a NEW power steering assist motor O-ring seal IS needed.

1. Remove the power steering assist motor. Refer to *Power Steering Assist Motor Replacement* in SI.
2. Install the new power steering assist motor. Refer to *Power Steering Assist Motor Replacement* in SI.
