Recall Bulletin

PRODUCT SAFETY RECALL

SUBJECT: Transmission Shift Cable Fracture

MODELS: 2004-2007 Chevrolet Malibu Maxx
2004-2008 Chevrolet Malibu
2005-2008 Pontiac G6
2007-2008 Saturn AURA
Equipped with 4-Speed Automatic Transmission (ME7/MN5)

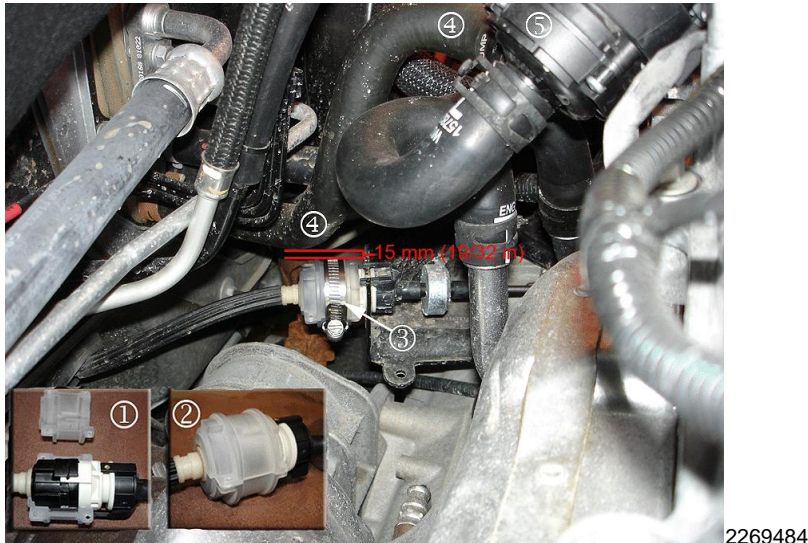
Hybrid vehicle shown. Combustion engine vehicle is similar.

- (1) Clam Shell in Two Pieces
- (2) Clam Shell Around Shift Cable Locking Tabs
- (3) Clamp on Clam Shell
- (4) Inlet Coolant Hose and
- (5) Heater Cooler Pump.

5. Install the clam shell (1) (2) over the shifter cable locking tabs.
6. Install the service clamp over the clam shell (3). Position the clamp fastener head away from the inlet coolant hose (4). **Tighten the clamp to 4 N·m (35 lb-in).**
7. Ensure that there is 15 mm (19/32 in) of clearance between the inlet coolant hose (4) and the clam shell (3). On hybrid equipped vehicles, it may be necessary to reposition the inlet coolant hose (4) to achieve the required 15 mm (19/32 in) of clearance. **To reposition the inlet coolant hose (4) on hybrid equipped vehicles, locate the heater cooler pump (5) and perform Steps 7.1-7.5.**

Caution: Do not kink or damage the inlet coolant hose (4) when repositioning the hose to obtain the 15 mm (19/32 in) clearance. To avoid damaging the hose clamp, use J-38185 or equivalent hose clamp pliers to loosen the hose clamp.

- 7.1. Remove the generator control module cover. Refer to *Generator Control Module Cover Replacement* in SI.
- 7.2. Using J-38185 or equivalent hose clamp pliers, loosen the inlet coolant hose (4) connected to the heater cooler pump (5). Note the location of the clamp on the inlet coolant hose (4).

- 7.3. Rotate the inlet coolant hose (4) clockwise until 15 mm (19/32 in) of clearance between the inlet coolant hose (4) and clam shell (3) is achieved.
 - 7.4. Ensure that the inlet coolant hose clamp is secure on the inlet coolant hose (4) in the production location.
 - 7.5. Install the generator control module cover. Refer to *Generator Control Module Cover Replacement* in SI.
8. Close the hood.
