PRODUCT SAFETY RECALL

SUBJECT: Front Safety Belt Anchor

MODELS: 2009-2014 Buick Enclave
2009-2014 Chevrolet Traverse
2009-2014 GMC Acadia
2009-2010 Saturn Outlook

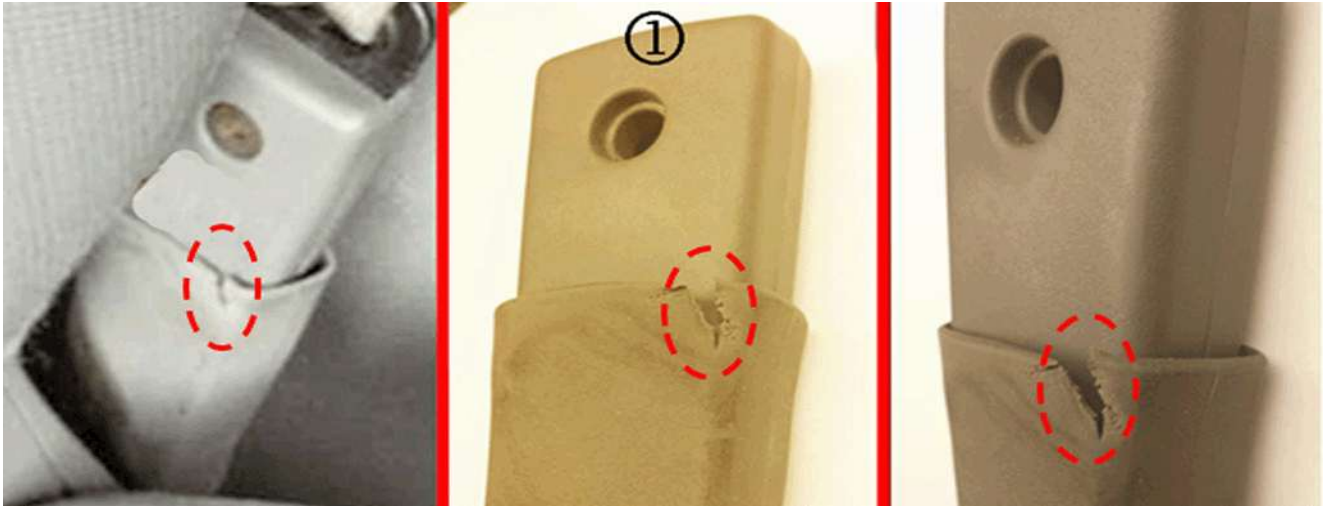
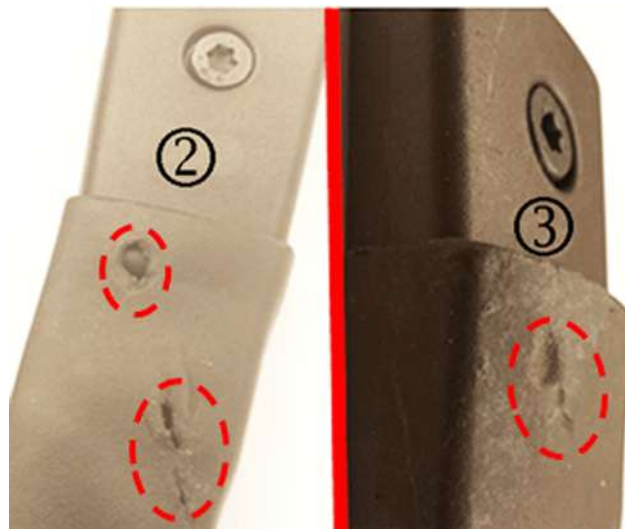
2. Inspect the seat belt anchor plate tensioner sleeve for any tears (1), holes (2) or wear (3).
 - If the driver **AND** passenger seat sleeves show no visible tears, holes or wear – Proceed to the *Rework Service Procedure*.
 - If either **ONE, OR BOTH**, of the driver and/or passenger seat sleeves show tears, holes or wear – Proceed to the *Rework Service Procedure* for the **UNDAMAGED** sleeve, then continue on to *Front Seat Belt Tensioner Replacement Procedure* for the **DAMAGED** sleeve(s).
