# Recall Bulletin

## PRODUCT SAFETY RECALL

**SUBJECT:** Unintended Ignition Key Rotation

**MODELS:** 2005-2009 Buick Allure (Canada)  
2005-2009 Buick LaCrosse  
2006-2011 Buick Lucerne  
2000-2005 Cadillac DeVille  
2006-2011 Cadillac DTS  
2006-2007 Chevrolet Monte Carlo  
2006-2013 Chevrolet Impala  
2014 Chevrolet Impala Limited (U.S. Fleet Only)

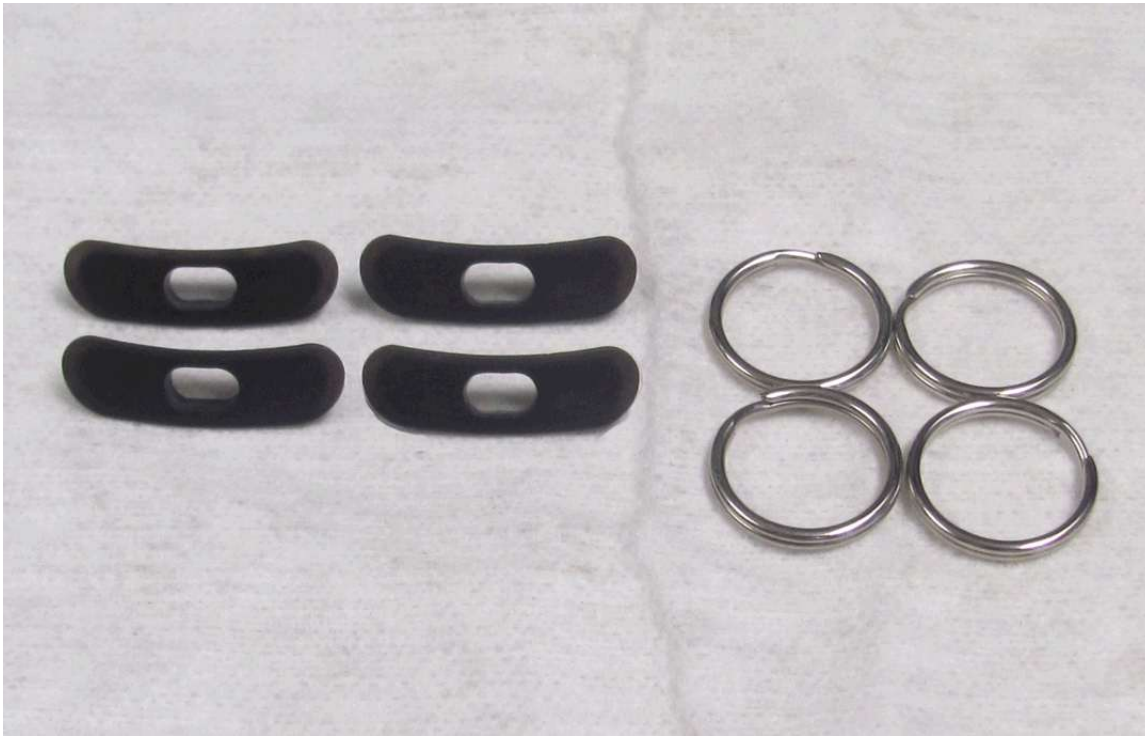
3970365

**Note:** Locate the four key inserts and four 16 mm rings. Two key inserts are required to modify one key. Two 16mm key rings are required for each key repair.

**Note:** If the key slot is too small or large for the insert, use the two-piece key cover repair. If the head of the insert does not cover the entire slot, the key insert repair cannot be used.

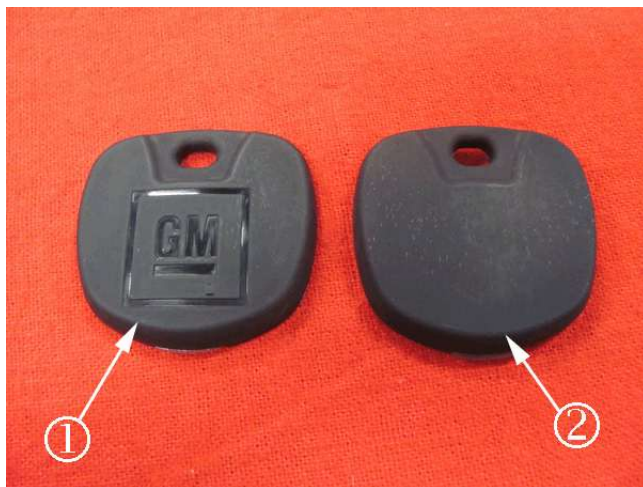
3971010

**Note:** There is a front and back key cover. The front key cover has a GM logo on it (1). The back key cover is blank (2).

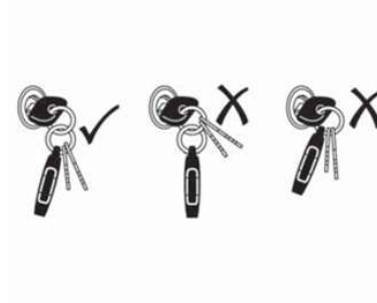
The combination and size of the rings that came with your keys were specifically selected for your vehicle. The rings are connected to the key like two links of a chain to reduce the risk of unintentionally moving the key out of the RUN position. Do not add any additional items to the ring attached to the ignition key. Attach additional items only to the second ring, and limit added items to a few essential keys or small, light items no larger than an RKE transmitter.
