PRODUCT SAFETY RECALL

SUBJECT: Driver Door Switch Short Circuit

MODELS: 2006-2007 Buick Rainier
2006 Chevrolet TrailBlazer EXT
2006-2007 Chevrolet TrailBlazer
2006 GMC Envoy XL
2006-2007 GMC Envoy
2005-2007 Saab 9-7X
Previously Repaired in Safety Recall 12180

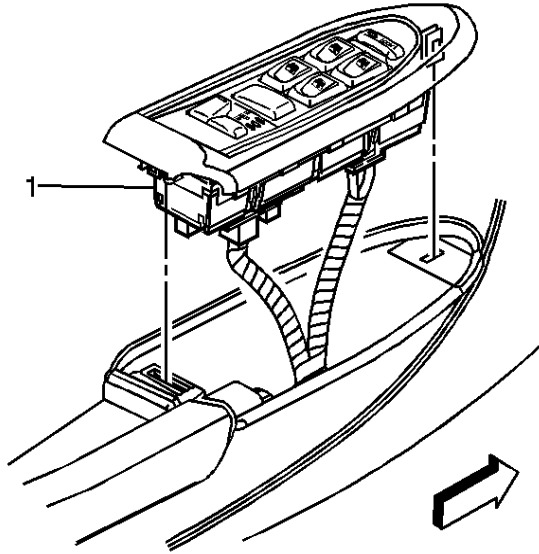
690976

If fluid, such as melted snow containing road salt, enters the driver's door module, it may cause corrosion that could result in a short in the circuit board. A short may cause the power door lock and power window switches to function intermittently or may stop working. A short may cause overheating, which could melt components of the door module, producing odor, smoke, or a fire. Additionally, the windows may raise or lower themselves, without user input. These conditions

Install new driver side door lock and side window switch. Refer to *Door Lock and Side Window Switch Replacement - Driver Side* in SI.
