Recall Bulletin

PRODUCT SAFETY RECALL

SUBJECT: Incomplete Weld on the Seat Hook Bracket Assembly

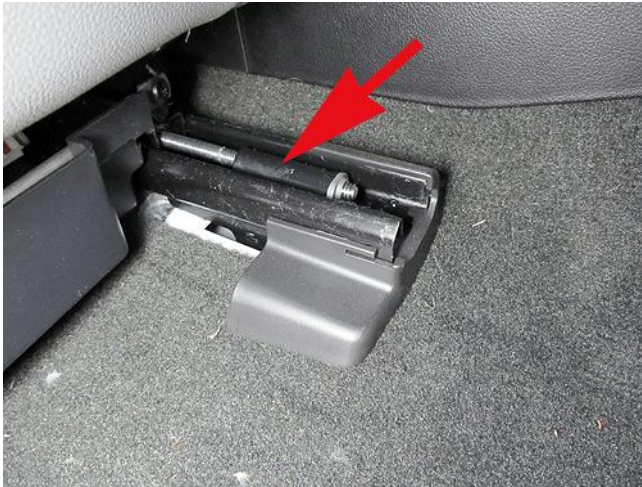
3960106

Note: On vehicles equipped with power seats, the inspection area is under the threaded rods on the seat track.

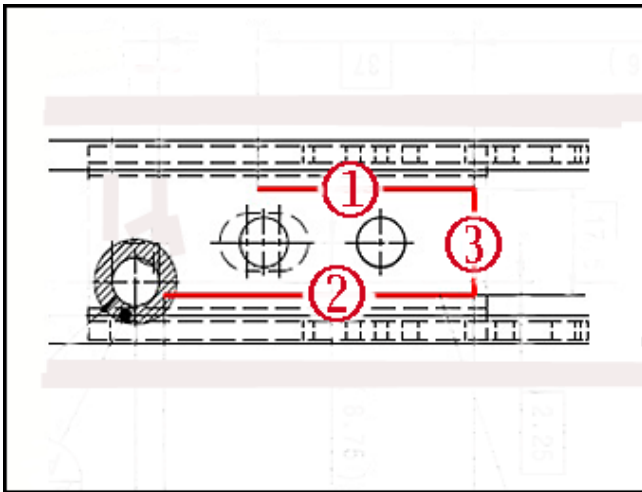
3963505

3. Illuminate the inspection area with a flashlight. Inspect the weld and ensure there are no obvious skips or gaps. For example, if the weld has an inconsistent appearance and/or texture but it contains metal from one end to the other, it is not an obvious skip/gap. An example of an obvious skip/gap would be if metal was actually missing from part of the weld. Using a ruler, measure the length of the weld penetrations on the seat track.

- Ensure the short weld length is a minimum of 35 mm (1.38") in length (1).
- Ensure the long weld length is a minimum of 51 mm (2.0") in length (2).
- Ensure the cross car weld connects to both of the parallel welds (3).
- Repeat this inspection on all four front seat tracks (*).

4. If all of the welds pass the inspection, the repair is complete. If any of the welds **do not meet the specification**, proceed to the *Seat Cushion Frame Replacement* section below.

If the vehicle fails the seat frame mounting hook weld inspection above, it will be necessary to replace the related seat cushion frame by ordering the standard replacement part number listed in the parts catalog for the VIN being serviced. Refer to *Driver or Passenger Seat Cushion Frame Replacement* in SI for replacement procedure.
