Service Bulletin

SPECIAL COVERAGE

SUBJECT: Special Coverage Adjustment – Unable to Remove Ignition Key

MODELS: 2005-2010 Chevrolet Cobalt
2006-2011 Chevrolet HHR
2006-2010 Pontiac Solstice
2007-2010 Pontiac G5
2005-2006 Pontiac G4/Pursuit
2007-2010 Saturn Sky
2003-2007 Saturn Ion
Equipped with Automatic Transmission

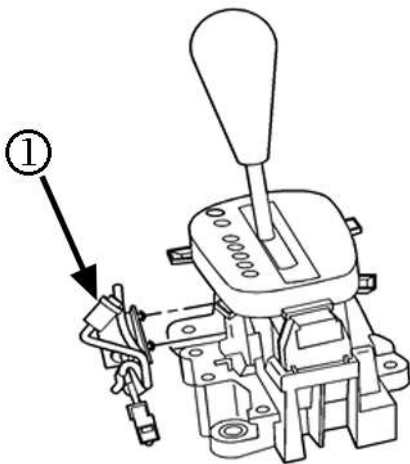
4043711

Important: For Ion models only, refer to *Diagnostic Starting Point - Automatic Transmission Shift Lock Control* and as necessary, *Shift Lock Control Solenoid (1) Replacement* in SI.
