APPLICABILITY: 2005-13MY Legacy and Outback Models with 5AT **NUMBER:** 16-91-14
 2006-13MY Tribeca **DATE:** 01/29/14

SUBJECT: Correction to Diagnostics for 5AT-Related DTCs:
 P0743, 748, 753, 758, 763, 768 and 773

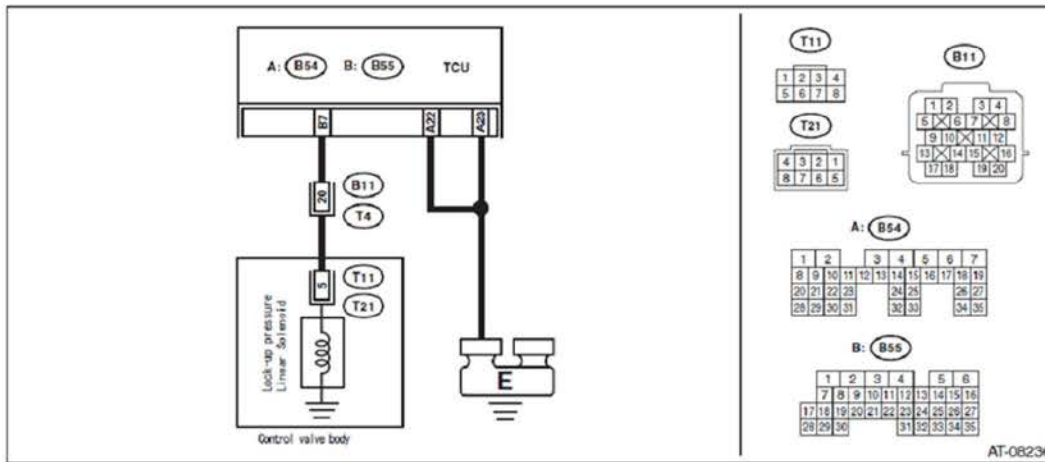
The connector number described above (T11) is the vehicle harness connector between the transmission control module and control valve body as shown in the schematic shown on pg. 2). The check is to measure the resistance between transmission ground and control valve body connector (T21), pin 5. Connector T11 should be labeled T21 (valve body harness connector).

Step	Check	Yes	No
5. CHECK LOCK-UP SOLENOID. Measure the resistance between transmission ground and control valve body connector Connector & terminal (T21) No. 5 — Transmission ground:	Is the resistance 3 — 9 Ω?	Go to step 6.	Replace the control valve body.
