Technical Service Bulletin

92 Rattle from instrument panel area

92 13 07 2021833/5 March 4, 2013. Supersedes Technical Service Bulletin Group 92 number 13-06 dated February 1, 2013 for reasons listed below.

Model(s)	Year	VIN Range	Vehicle-Specific Equipment
TT (8J)	2007 - 2009	All	Not Applicable
TT (8J)	2010	000001-018286	Not Applicable

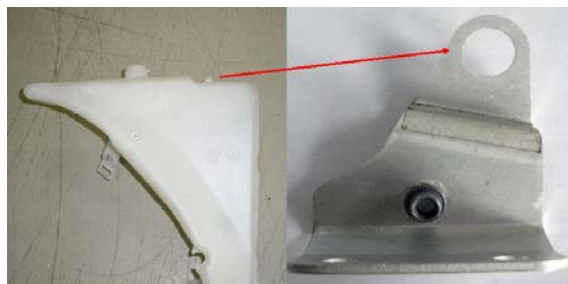
Rattling noises appear to be coming from the front of the vehicle or from the instrument panel area.

Excessive free play between the mounting bracket for the windshield washer reservoir and the washer reservoir (Figure 1).

Figure 1. Area of contact between the mounting bracket for the windshield washer reservoir and the washer reservoir.

Self-adhesive foam pad **8E5868739** attached to the mounting bracket.

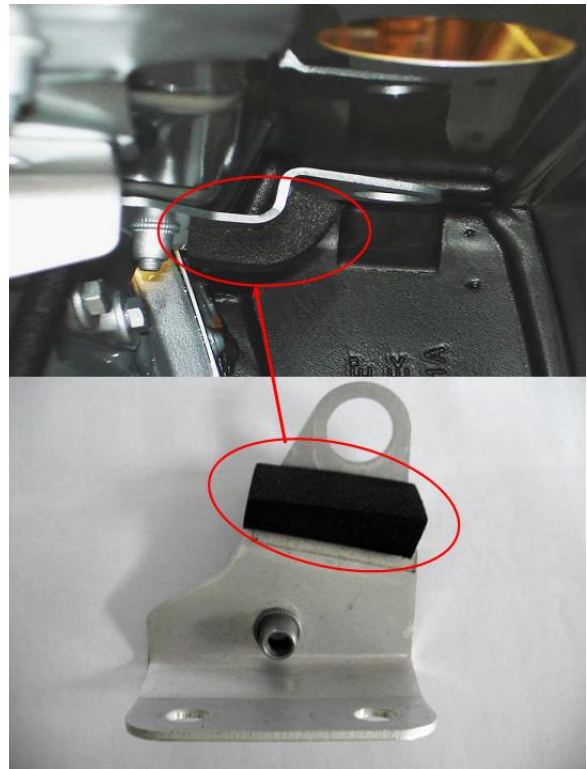
Figure 2. Area to attach the foam pad.

1. Remove the front wheel housing liner.
2. Check the windshield washer reservoir for free play in the mounting bracket.
If there is free play in the mounting bracket, attach the self-adhesive foam pad **8E5868739** on the mounting bracket as shown in the illustration (Figure 2).
