SERVICE BULLETIN

APPLICABILITY: 2010-2013MY Legacy and Outback **NUMBER:** 12-147-13R
SUBJECT: Pop Sound from Right Rear Wheel Apron Area **DATE:** 03/08/13
REVISED: 07/08/14

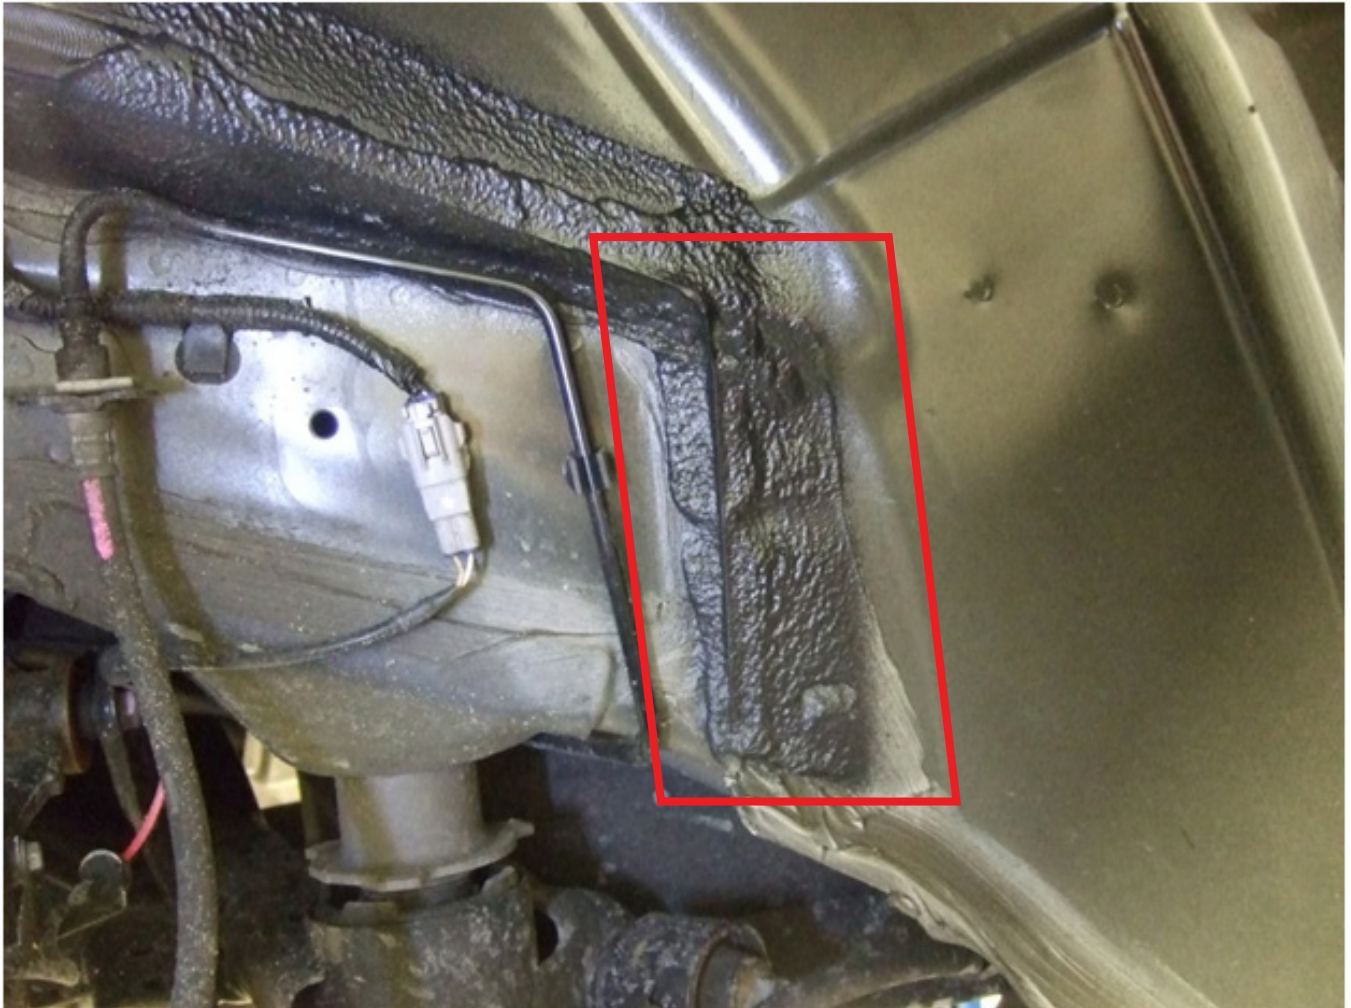
The undercoating needs to be removed from the area outlined.

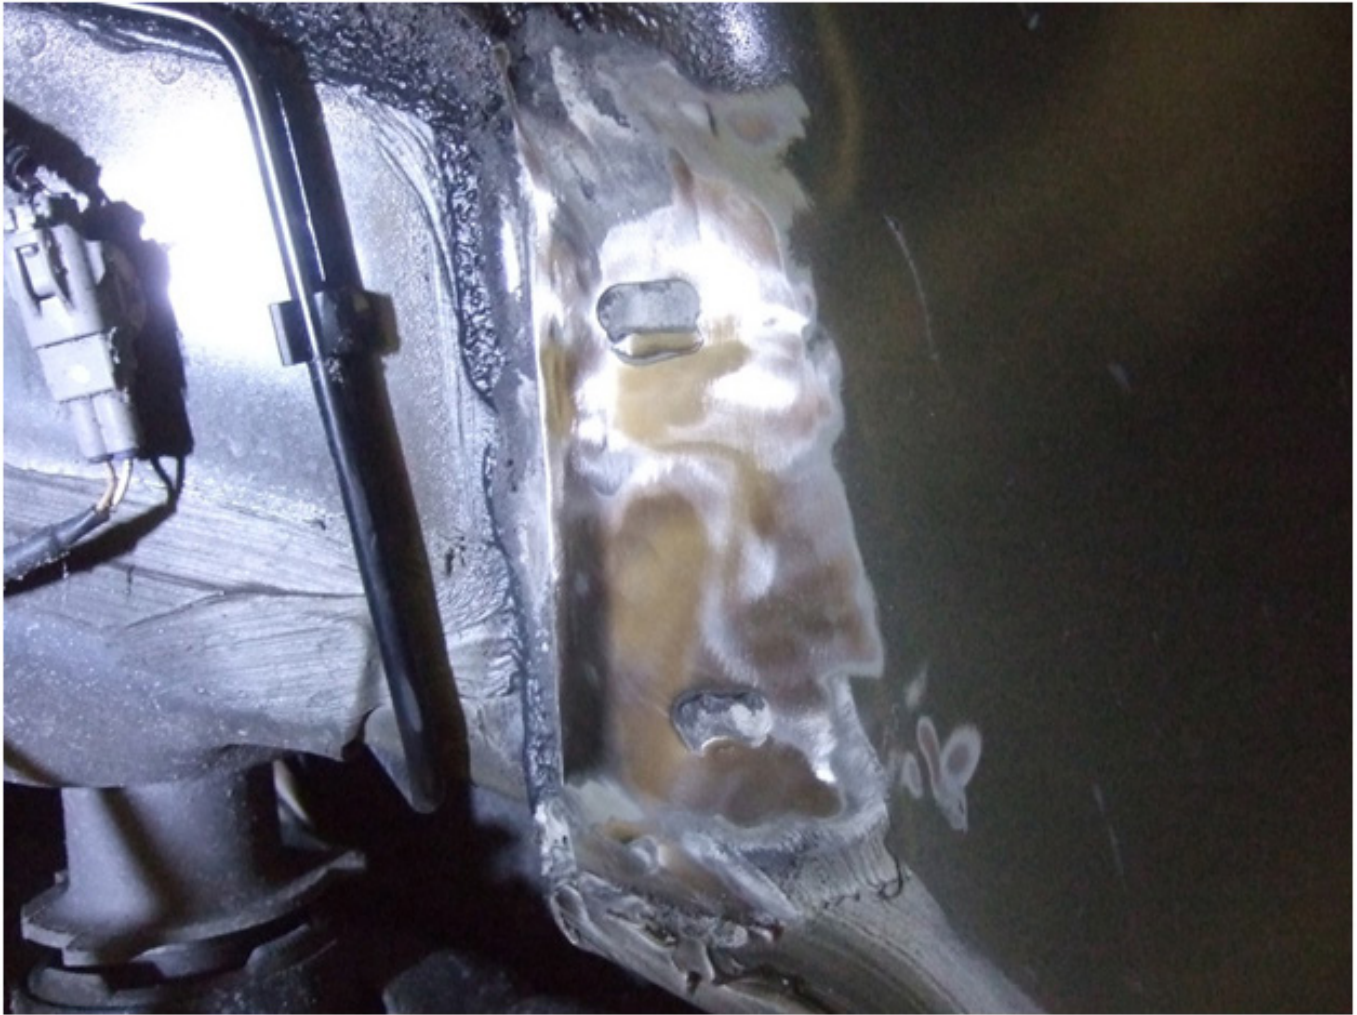
Photo of undercoating removed.

There are 3 layers of sheet metal which are secured together.

Outer - Wheel apron rear

Middle – Side sill inner rear

Inner – Frame side rear lower front

The outer wheel apron is secured by 2 welds to the middle side sill.

The middle side sill is secured by 6 welds to the inner frame.
