**NUMBER:** 18-011-13  
**GROUP:** Vehicle Performance  
**DATE:** March 06, 2013

Flash: MIL Illumination P050B and/or Rattle/Clatter Sound on Cold Start-up

2011 - 2013      MK                              Compass/Patriot

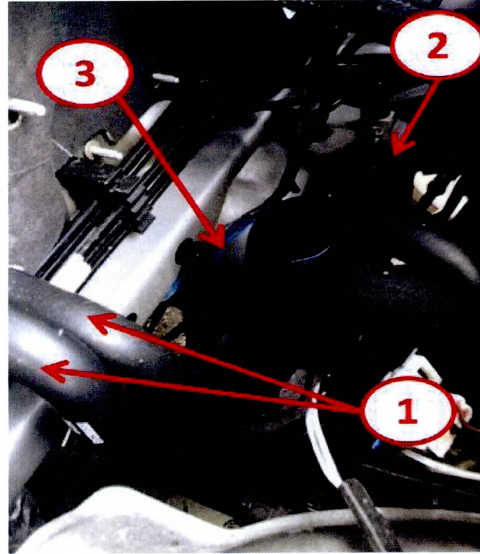
**Fig. 1 Purge Solenoid Wire Harness**

- 1 - Heater Core Supply and Return Hoses
- 2 - Purge Solenoid
- 3 - Purge solenoid Wire Harness

5. Without removing the pressure cap and with system not under pressure, turn draincock counterclockwise to open.
6. The coolant reserve bottle should empty first, then remove the pressure cap.
7. Allow cooling system to drain completely.
8. Remove both supply and return heater core hoses.
9. Install new heater core supply hose (p/n 05058822AB) and heater core return hose (p/n 05058823AB).
10. Install the right wheel inner splash shield.
11. Remove the engine cover.
12. To ensure that the purge solenoid wiring harness ([Fig. 1](#)) does not come in contact with the heater hoses, the wire harness will require a slight modification.

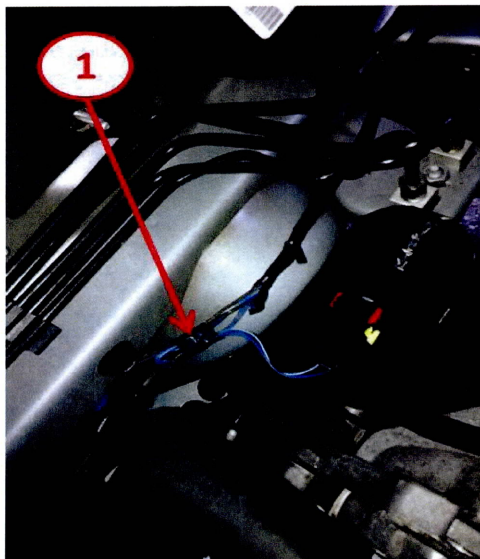
**Fig. 2** *urge Solenoid Wire Harness Routing*

1 - Secured Purge Wire Harness

13. Loosely pull the purge solenoid wire harness straight and create a bend in the harness approximately 10mm (0.40 in. or 3/8 - 7/16 in.) away from the harness retaining clip edge. This bend will also create a natural bend after the current spot tape on the harness. Then, apply 3 - 4 wraps of electrical tape securing the bend to the harness as shown in (Fig. 2).
