# Technical Service Bulletin

## 94 Headlight Flickering or Warning On in Cluster (All Xenon Headlights)

94 13 10 2029194/4 March 4, 2013. Supersedes Technical Service Bulletin Group 94 number 13-03 dated February 1, 2013 for reasons listed below.

Model(s)	Year	VIN Range	Vehicle-Specific Equipment
Q7	2010	All	Premium Plus and Prestige
	2011	All	
	2012	All	
	2013	All	
	2014	All

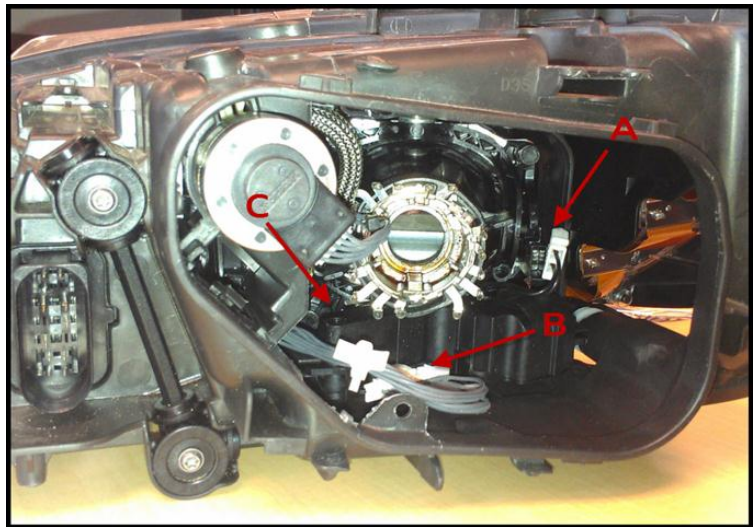
**Figure 1.** Back of Tri-Xenon Headlight showing three connectors, "A", "B", "C". Bi-Xenon Headlight will only have a single "A" connector.

1. Verify which side is affected based on the DTC or customer complaint and remove the affected headlamp per the instructions listed in the ElsaWeb Repair Manual: *Repair Manual*>>*Electrical System*>>*94 Exterior Lights, Switches*>>*Removal Installation*>>*HID Headlamp, From MY 10*
2. Remove the covers from the back of the headlamp housing.
3. Physically check all the connectors inside the headlamp housing for proper seating and visually inspect the locks to ensure they are fully engaged (Figure 1).

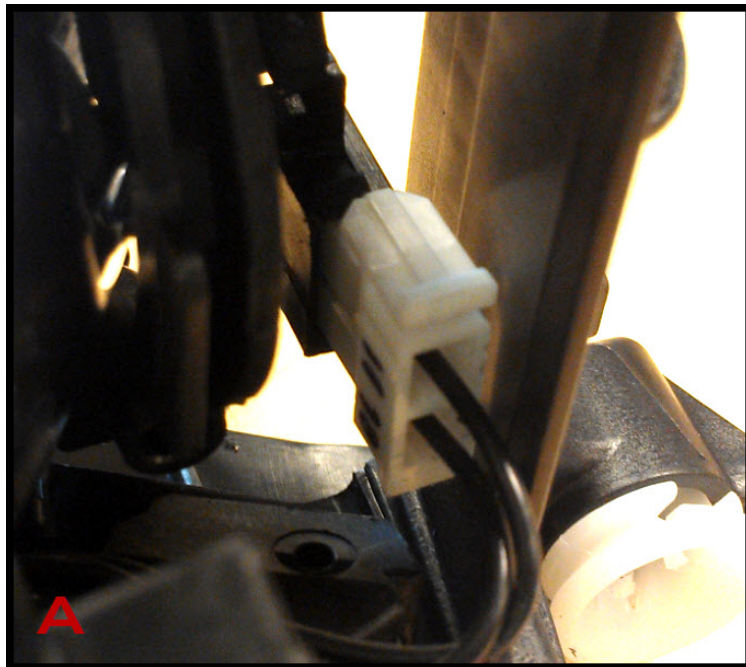
Connector “A” (Figure 2, A) can be seated but not fully engaged. When pushing on this connector the projector will swivel, so it is important to hold the projector housing when applying pressure to the connector.

*Figure 2. Connector “A” shown not fully seated.*

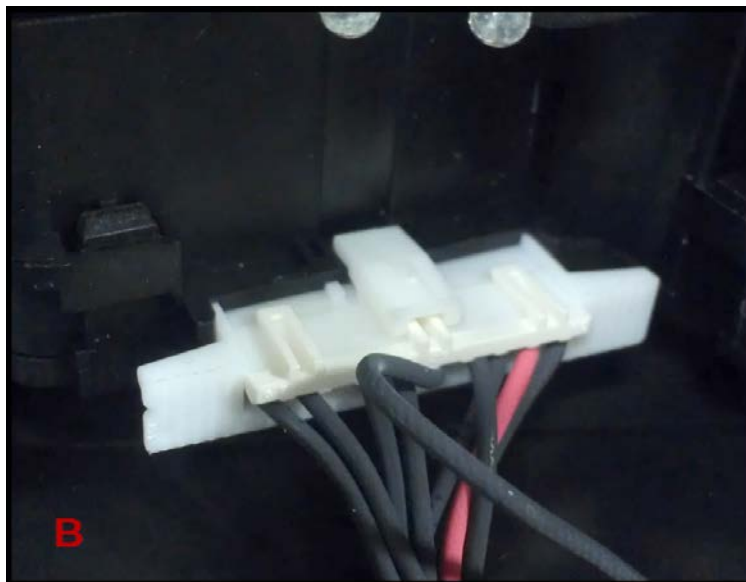
Connector “B” (Figure 3, B) can be fully locked into place but it can be rotated 5-10 degrees off center. Therefore, it is important to ensure that the harness connector is seated parallel to the connector housing on the headlamp.

*Figure 3. Connector “B” shown off center.*

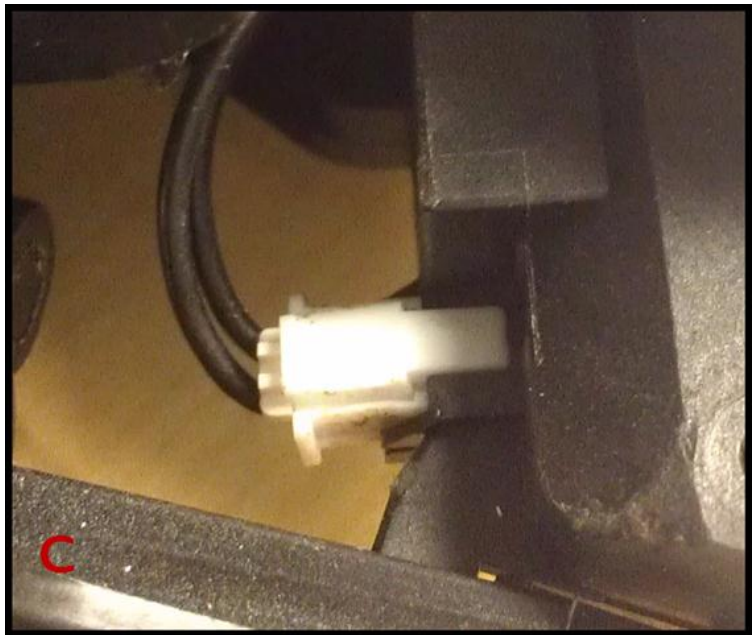
*Figure 4. Connector “C” shown in the locked position.*

Connector “C” (Figure 4, C) is located behind the motor mechanism, which rests below the projector lens. This is a very small two-pin connector. Use caution when wiggling this connector because if it becomes fully disconnected, it is almost impossible to reconnect without using special tools. Place your finger, or a set of small bent pliers, on this connector and pull towards yourself to fully seat the connector.
