94 Water accumulation in Xenon headlights

94 13 14 2033536/1 April 5, 2013.

Technical Service Bulletin

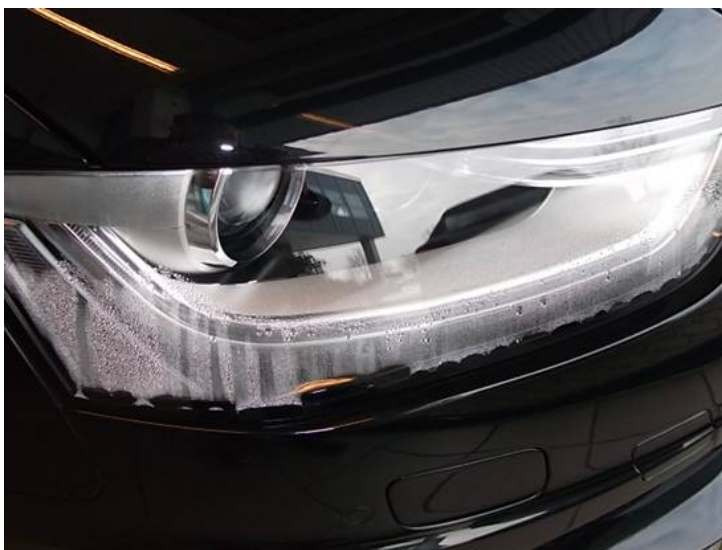
A significant amount of water is collecting at the base of the Xenon headlight lens (Figure 1).

No outside influence, such as rock chips, can be found. The headlights function normally.

Figure 1. Xenon headlight with a significant amount of water collecting at the base of the lens.

Under certain circumstances, water can enter through the headlight adjustment screw (A4), or through the bonding channel between the headlight housing and lens (A5).

Replace the affected headlight(s) only if a visible amount of water can be seen collecting at the base of the headlight lens(es). Refer to ELSAWeb: *Repair Manual*>>*Electrical System*>>*Electrical Equipment*>>*94 Exterior Lights, Switches*>>*Removal and Installation*>>*HID Headlamp, from MY 2012*>>*Headlamp Housing*.

Adjust headlights after installing them back in to the vehicle. Refer to ELSAWeb: *Repair Manual*>>*Electrical System*>>*Electrical Equipment*>>*94 Exterior Lights, Switches*>>*Diagnosis and Testing*>>*HID Headlamp, Adjusting*.
