Technical Service Bulletin

94 Moisture accumulation in headlamps

94 13 20 2028277/7 July 3, 2013. Supersedes Technical Service Bulletin Group 94 number 13-11 dated March 6, 2013 for reasons listed below.

Model(s)	Year	VIN Range	Vehicle-Specific Equipment
Q7	2010 - 2014	All	Not Applicable

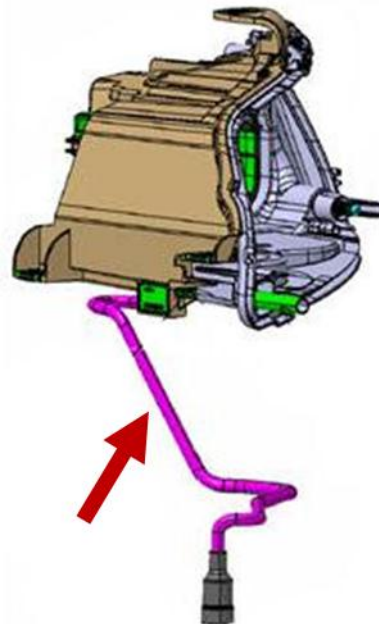
**Tip:** The updated ventilation hose is not connected directly to the headlamp housing. The hose routes downward from the headlamp carrier and between the radiator and bumper (Figure 3, arrow).

Figure 3. Mounting of updated ventilation hose.

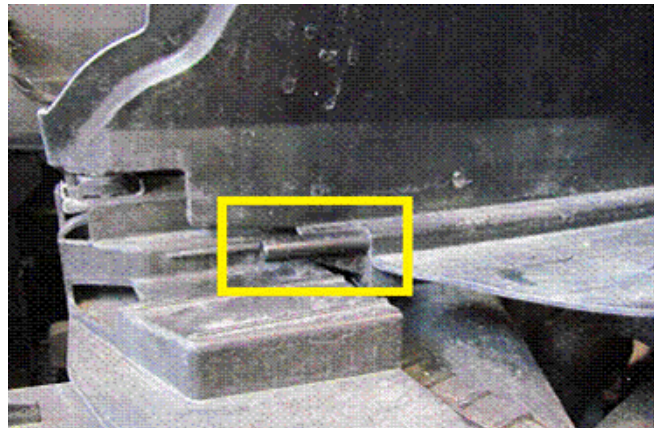
Figure 4. Headlamp ventilation guide tube.

- Each headlamp air ventilation tube must be sealed to protect against further moisture ingress (Figure 4).

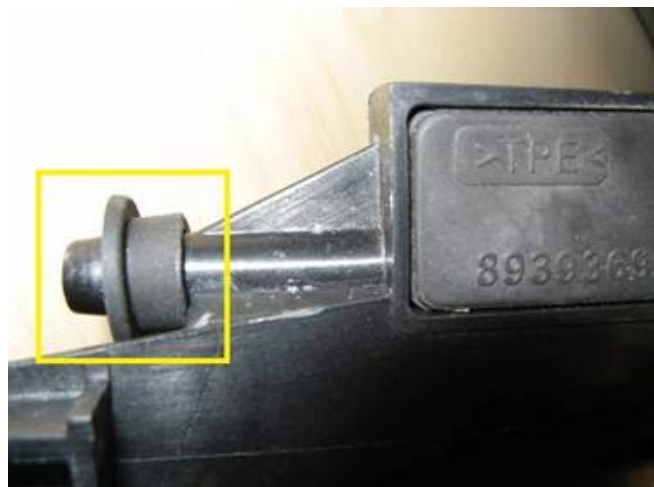
Figure 5. Ring seal installed on headlamp air tube.

- Install ring seal on headlamp air ventilation tube (Figure 5). The larger diameter of the seal faces the headlamp.

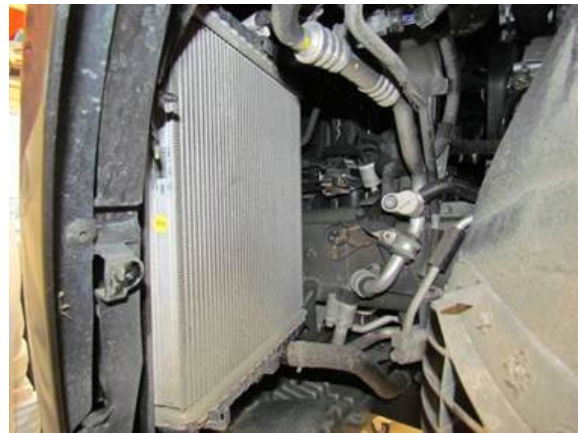
Figure 9. Charge air cooler exit air duct installed.

9. Affix left and right exit air ducts over the rear of the charge air coolers (Figure 9).

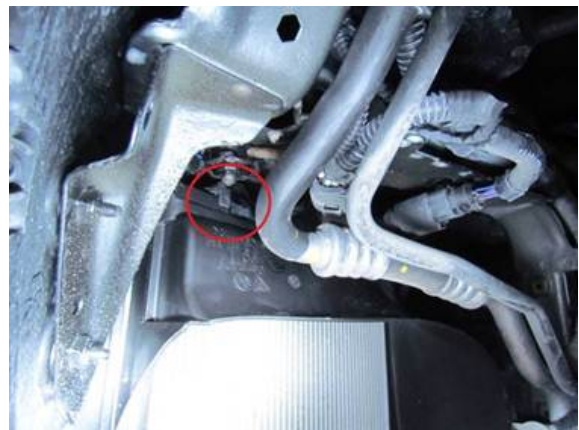
Figure 10. View of exit air duct affixed to mounting hook.

10. Inspect exit air duct attachment points to be sure that ducts are engaged properly over charge air cooler hooks (Figure 10).
