Service Bulletin

Bulletin No.: 07-02-32-002N

Subject: Hydraulic Power Steering System Leak – Required Diagnostic Actions

Models: 2005-2014 GM Cars and Trucks
Equipped with Hydraulic Steering

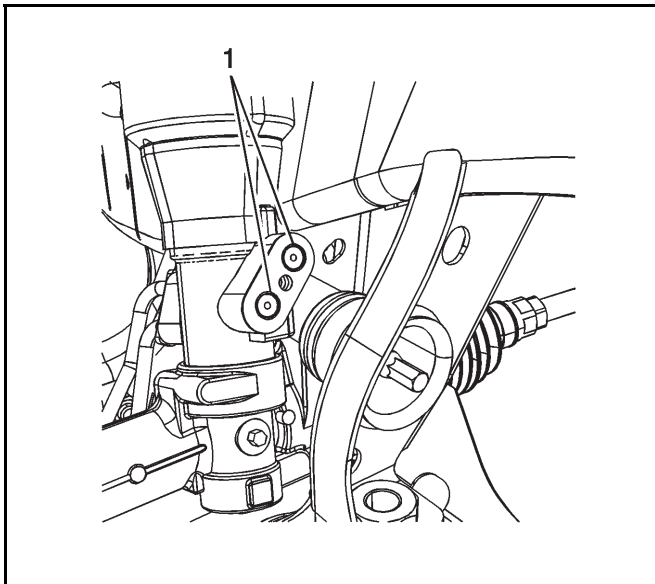
1492058

Some vehicles are equipped with a “duck-bill” style seal that is pierced by the power steering line during installation to the gear at vehicle assembly. Vehicles that are equipped with this type seal are:

Important: Only insert J-42640 just far enough in to the duck bill seal to get behind the duck bill seal's steel ring. Then using the tool pry against steel ring to remove the seal. Do not insert the tool too far into the duck bill seal and pry against the housing bore. Prying against the housing bore could scratch the housing bore and require steering gear replacement.

These seals are replaceable and any leak at the line to gear connection on these vehicles should be first addressed with a seal replacement. Use a J-42640 Steering Column Anti-rotation Pin (1) to remove the seals (2) and then install the new seals by hand and connect the power steering inlet and outlet line. This will seat the seals into the steering gear housing.
